Home Inspection Report

622 Trango Dr, Westminster, MD 21158

Tuesday July 7, 2020

0707 B

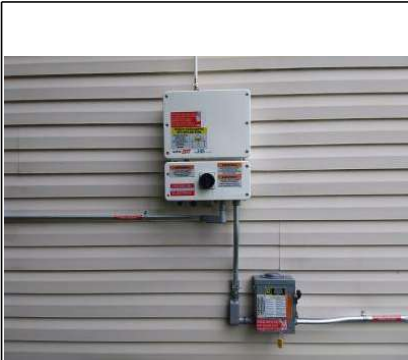
The solar system is new. Recommend and all service and maintenance guidance is followed.

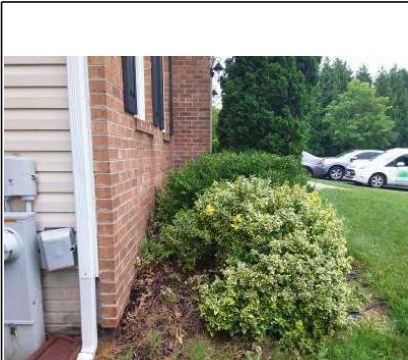
Vegetation should be cleared 12 to 18 inches away from the building to protect the integrity of the building materials.

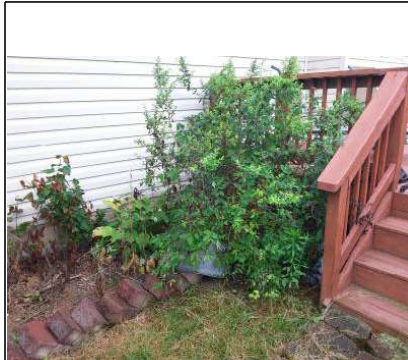
Second view of overgrown vegetation.

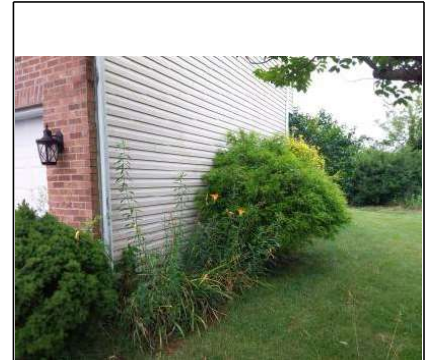
Overgrown vegetation on the right side of the house.

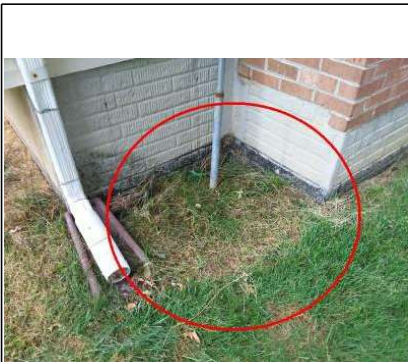
There is a negative grade in the left rear corner of house and the back of the house. The grade should be a 1 inch per foot fall away from the foundation for 6 feet.

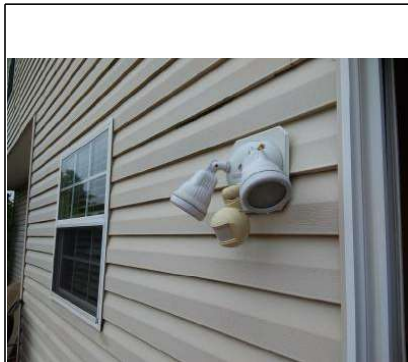
Photocell light on the deck does not work.

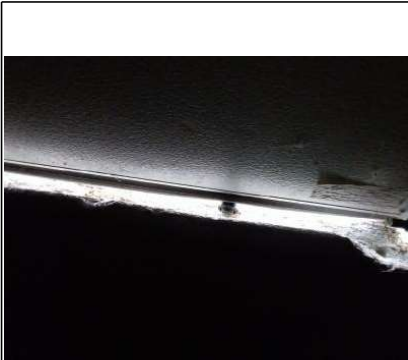
Contact auto reverse on the garage door does not work. This is a safety hazard.

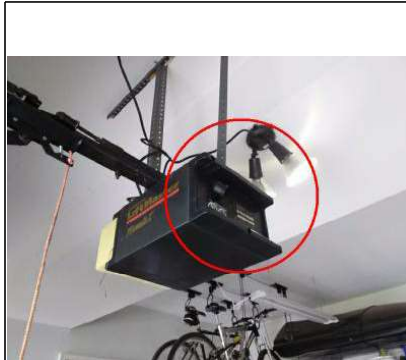
A light bulb and the lens is missing on the garage door opener.

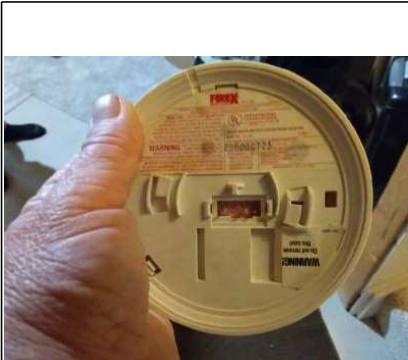
Smoke detectors throughout the house need to be replaced because they are over 10 years old. The replacements should be hardwired combination smoke and carbon monoxide detectors with sealed 10-year lithium ion battery backups in common areas. Smoke detectors inside of sleeping areas need not be equipped with carbon monoxide combination but should be hardwired with 10-year batteries.

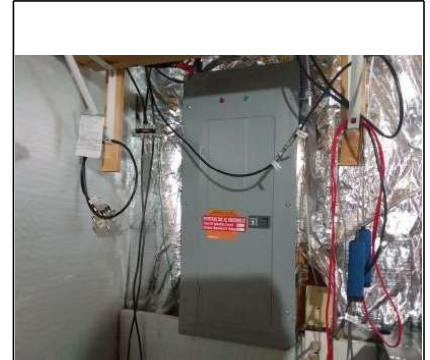
Position of electrical panel. Please keep clear in front of the panel to allow for easy access.

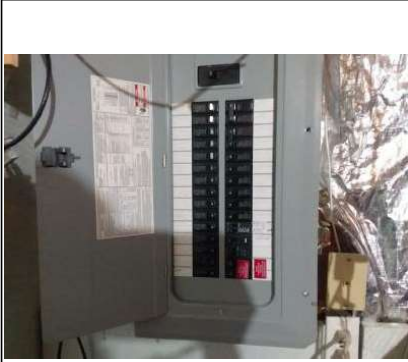
Panel is properly marked. There is no evidence of handyman wiring in the panel.

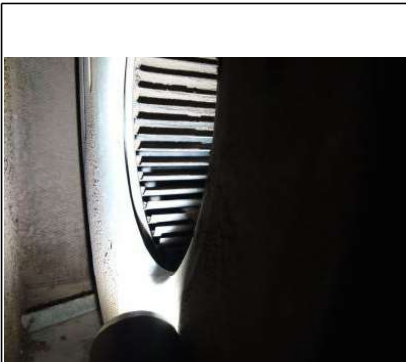
There is dust present on the blower fan blades. Consider duct cleaning.

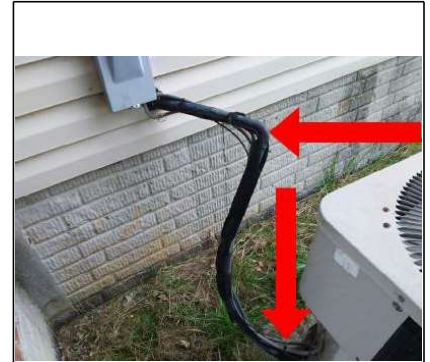
Insulation on refrigerant lines is damaged and should be replaced.

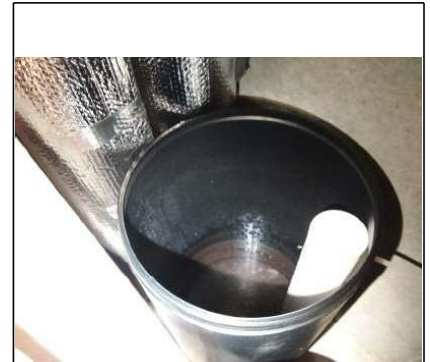
Salt reservoir needs to be filled.

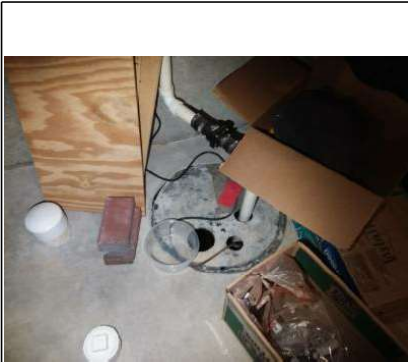
Sump pump lid should be sealed.

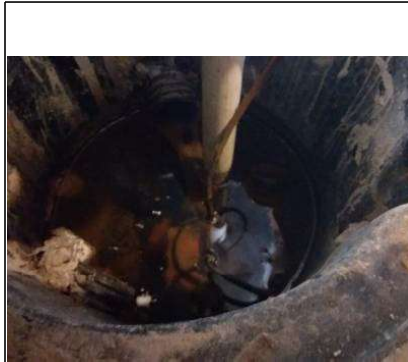
The sump pump does not work. This could lead to the possible flooding situation in the basement.

Comments Sump pump did not work at the time of the inspection. The pump should be replaced or made operational.

Sump pump did not work when tested.

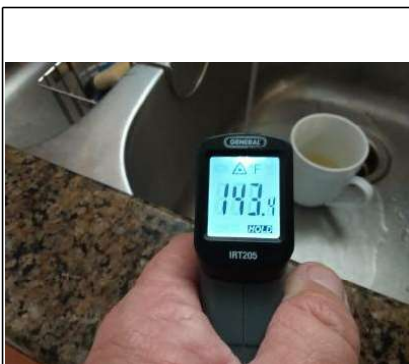
Comments and Actual Water Temperature The water heater temperature should be set at 120 degrees. The reading at the kitchen sink was 143 degrees which is considered to be a safety hazard.

Water temperature at kitchen sink is 143.4 degrees. This is a safety hazard.

Comments and Actual Water Temperature cont. Recommend adjusting the water temperature to an appropriate level.

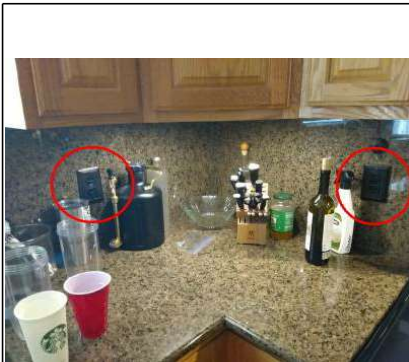
Two cover plates on the backsplash in the corner of the kitchen are loose.

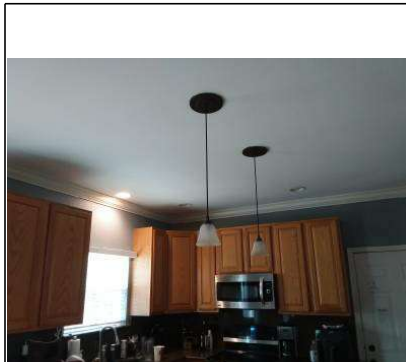
Recessed lights and pendant lights in the kitchen did not work at the time of inspection.

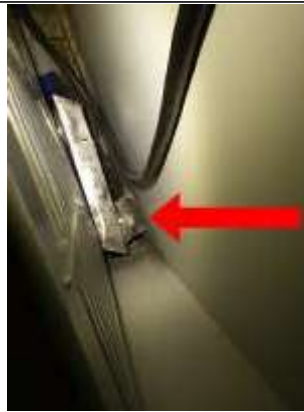
Ventline is loose at the connection and lint is collecting behind the dryer.

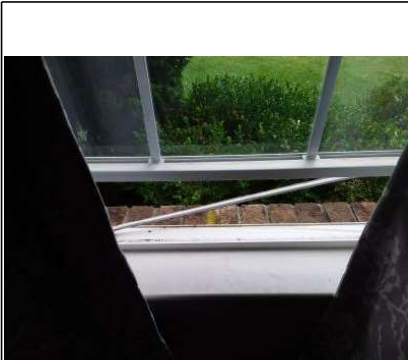
Insulation strip is loose on both windows.

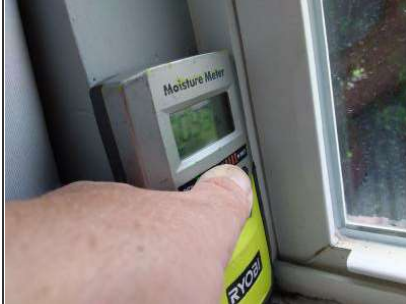
Moisture readings on all the window openings throughout the house are high indicating that there is a problem with the installation or the caulking system around the windows. Because the openings are drywall, the readings should be 0% moisture. Readings are between 78% moisture and 100% moisture. Recommend a qualified contractor evaluate the situation and make appropriate repairs.

Moisture in the window opening is 93%.

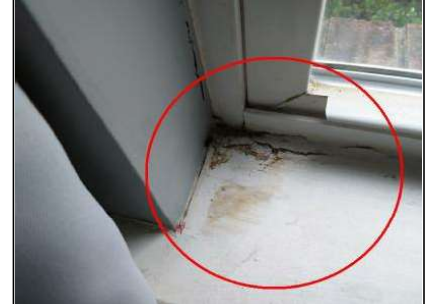
Signs of water damage on the windowsill.

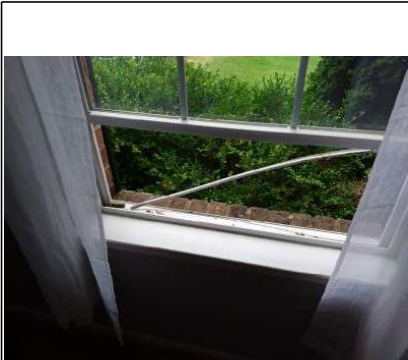
Insulation strip is loose on right window

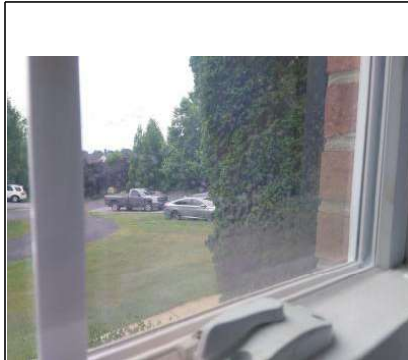
Top sash on left window appears to have an a broken seal

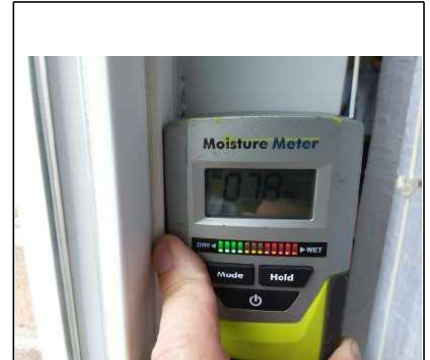
Moisture in the window opening is measured at 78%

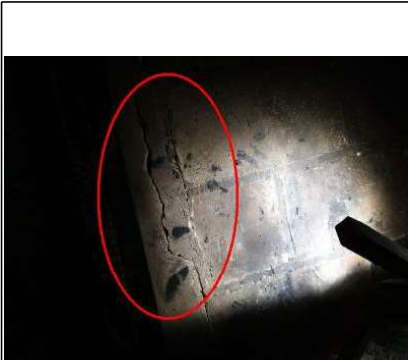
There is some cracking on the left front of the firebox in the fireplace.

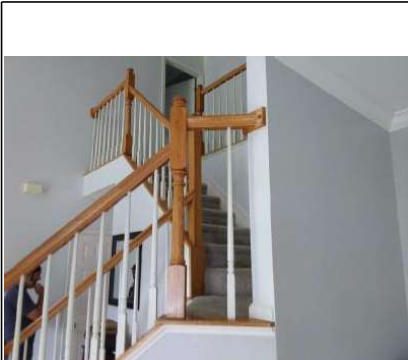
Baluster missing at first landing to upper stairs

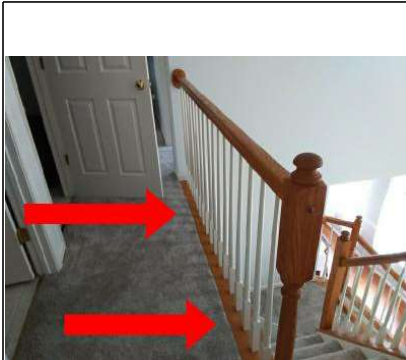
Railing in the upstairs hallway is loose.

Bottom rail on the flat rail in the hallway upstairs is loose.

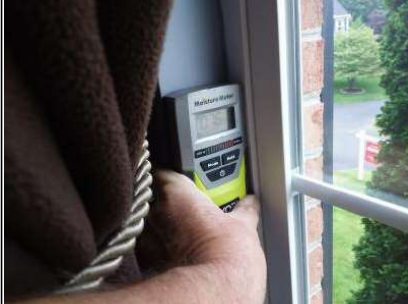
Moisture readings in the window openings are 76%

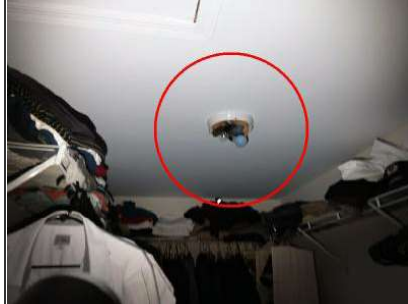
Globe for the light fixture in the closet is missing

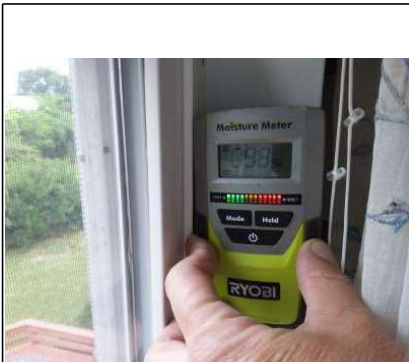
Moisture reading in the right window opening is 98%.

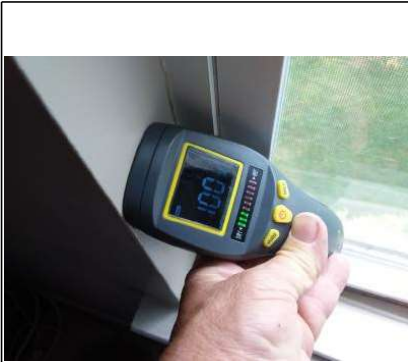
Moisture reading in the window openings at 100%.

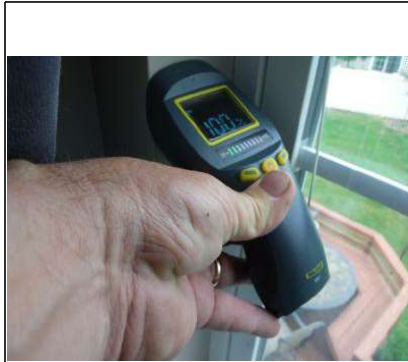
second view of moisture reading the window at 100%

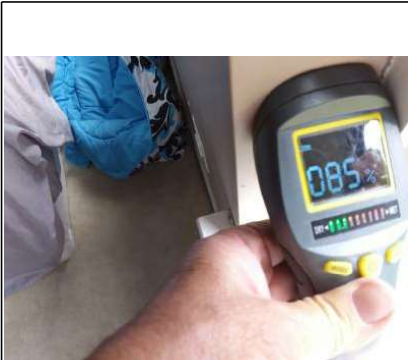
Moisture readings in front window are 85%

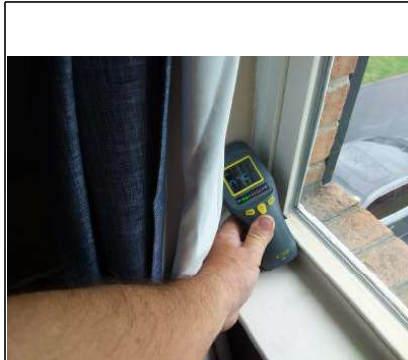
Second moisture reading at 75%

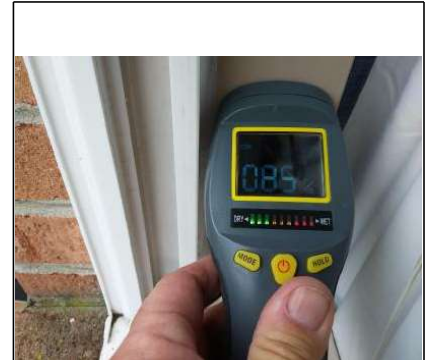
Moisture reading on the other window is at 85%.

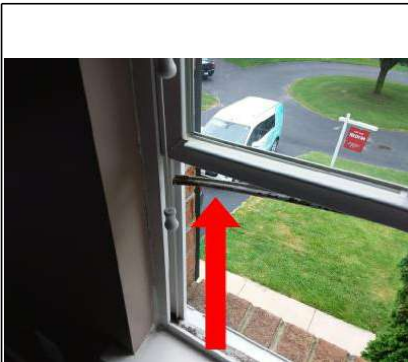
Insulation on the bottom of the window sash has come loose.
