Home Inspection Report

1200 Iroquois Dr, Crownsville, MD 21032

Wednesday August 4, 2021

0804 E

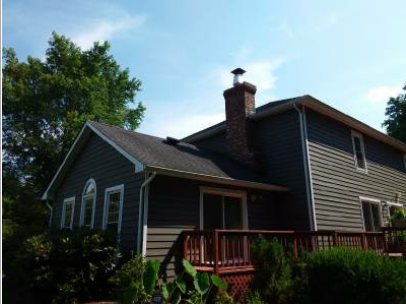
The owner indicated that the roof is 10 years old. It is recommended that a roof of this age be professionally inspected by a qualified roofer who can do a tune up.

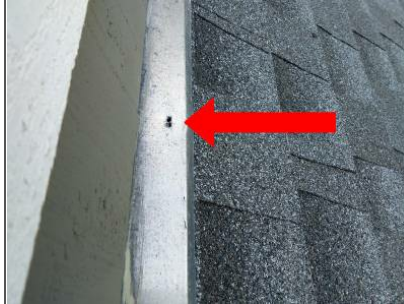
There are holes in the flashing under the front left windows on the upper level that need to be sealed.

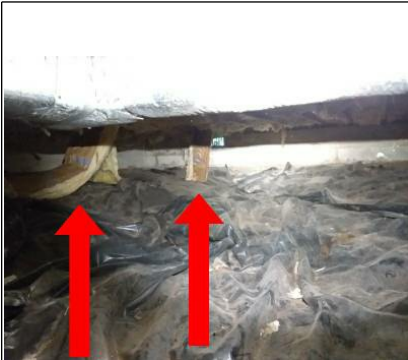
Some of the insulation in the crawl space has come loose and should be replaced.

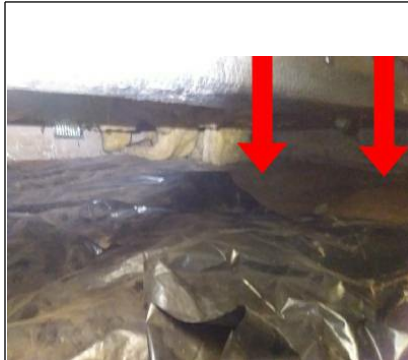
The vapor barrier does not cover the entire floor of the crawl space. Recommend that all dirt areas be covered.

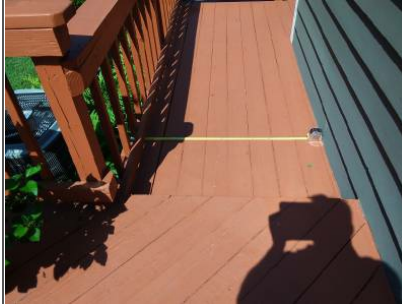
The walkway on the deck. These are improperly supported.

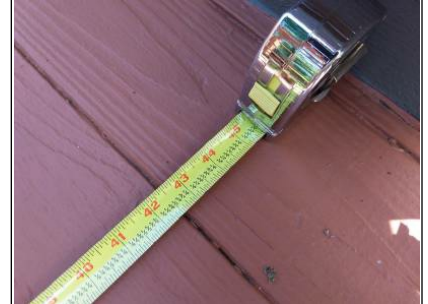
The walkway on the deck is 4' wide. This should be treated as a separate structure.

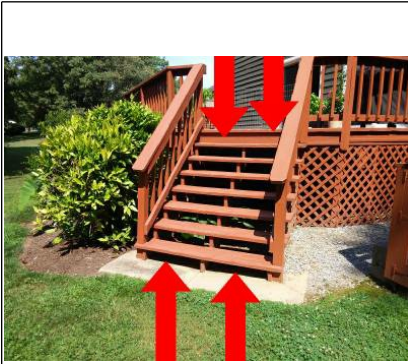
Stair stringers should be spread 16" apart. The main stairs for the deck are missing 2 stringers. Additionally, the stairs on the side of the house are missing a stringer.

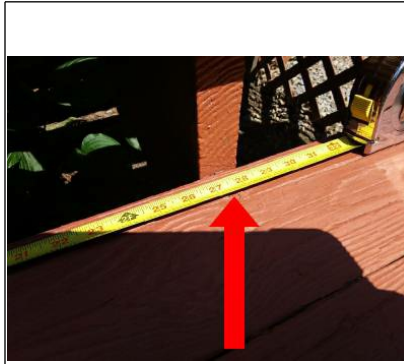
Stringers are spread 27 1/2 inches apart.

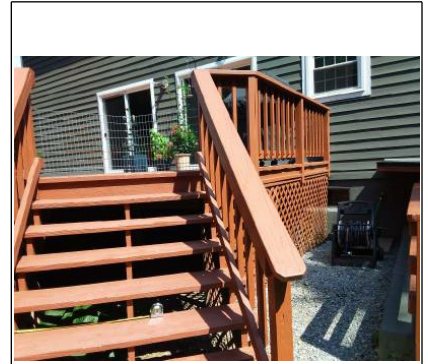
There is no graspable handrail on the staircase to the deck.

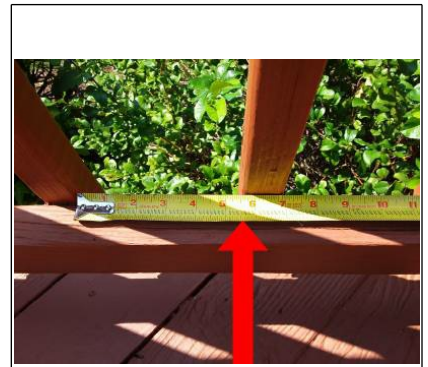
Baluster spacing is 5 1/2 inches.

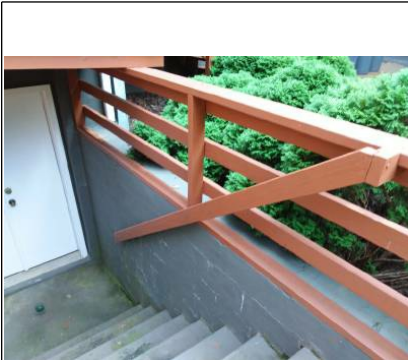
There is no graspable handrail on the rear steps.

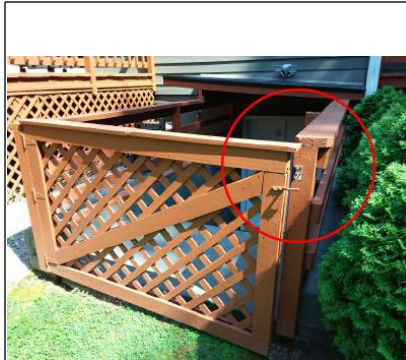
The swinging door for the rear step enclosure is sagging.

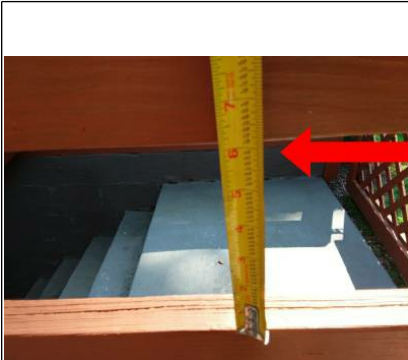
The gaps are 6 inches

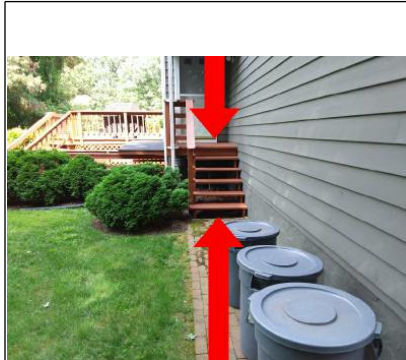
Stringer missing on side door stairs. This staircase does not have a graspable handrail.

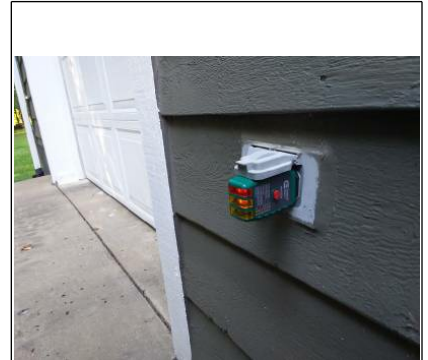
Outlet between the garage doors is not GFCI protected.

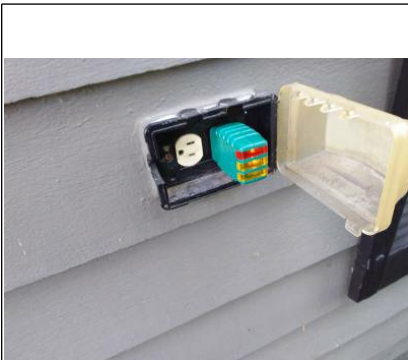
Front electrical outlet is not GFCI protected.

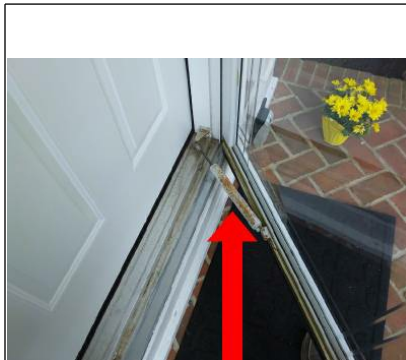
Bottom door closer shock absorber is rusted.

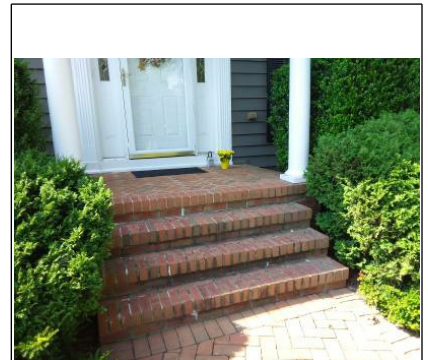
Front staircase should have a handrail. Any staircase that has 4 steps or more should have a handrail.

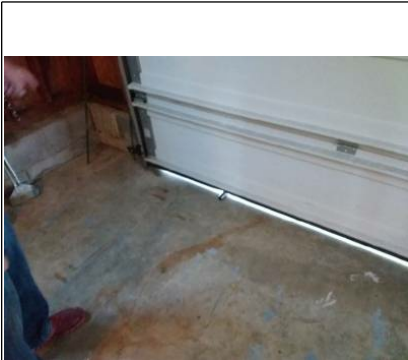
Contact auto reverse on the right garage door does not work.

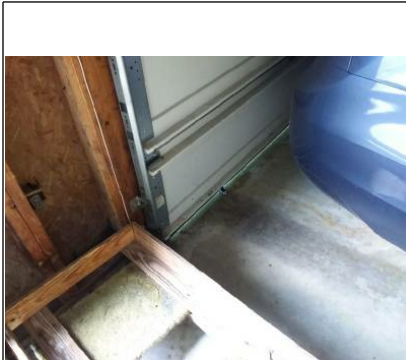
Contact auto reverse on the left garage door does not work.

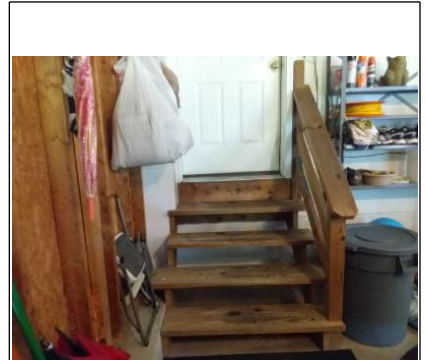
There is no graspable handrail on the stairs to the garage.

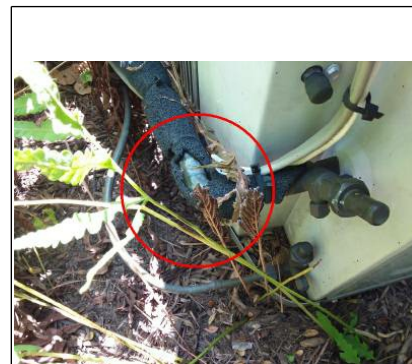
There is some torn insulation on the refrigerant line that should be replaced.

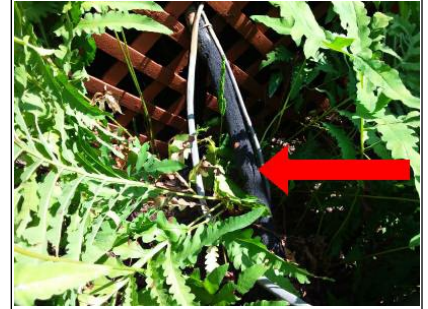
The insulation on the refrigerant lines should be replaced.

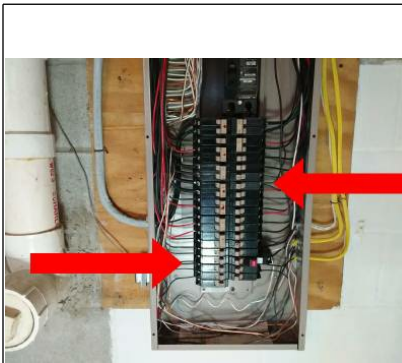
There are two double taps in the panel.

Electrical: The panel was opened and 2 double taps were found bound. The outside outlets are not GFCI protected. Recommend that these items be repaired by a licensed electrician.

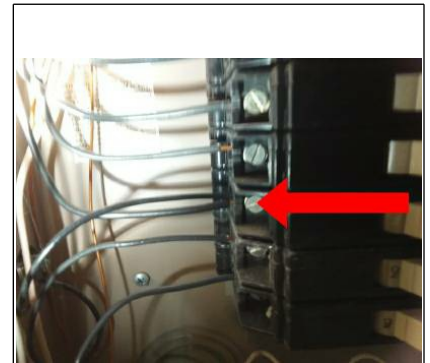
Close up of left double tap.

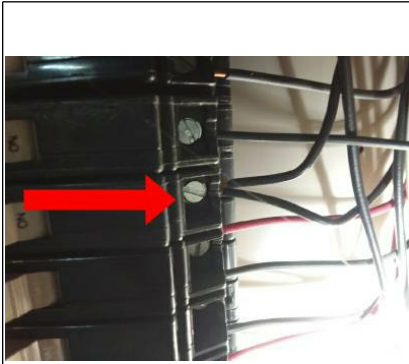
Close up of right double tap.

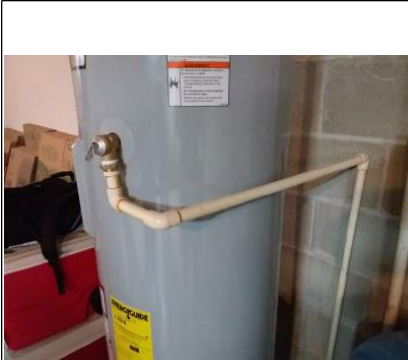
Pressure relief a valve extension drains into the sump pump crock. Recommend replacing with a straight pipe that terminates 6 to 8" from the floor so that water drops can be seen if valve begins to fail.

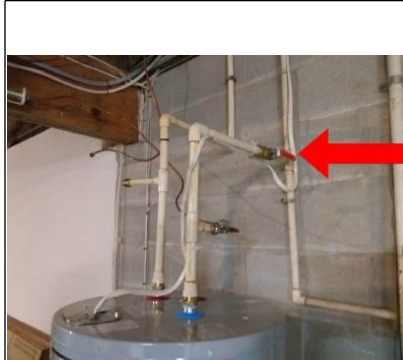
Shut off valve. Note that there is no expansion tank.

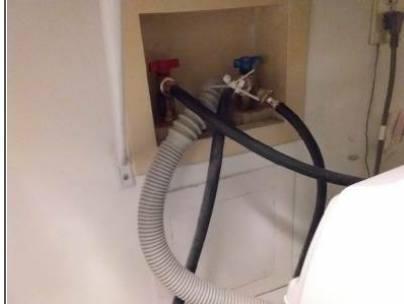
Recommend switching out water supply lines to reinforced supply lines. There are three supply lines.

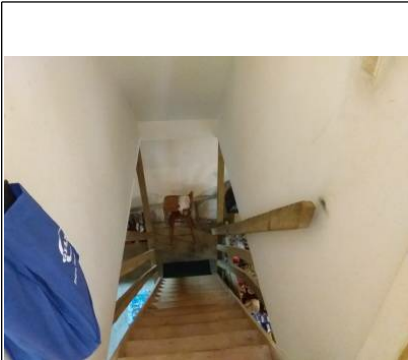
The handrail to the basement is not a graspable handrail.
