# Home Inspection Report

2016 Damon Dr, Mount Airy , MD 21771

Sunday August 15, 2021

0816 A

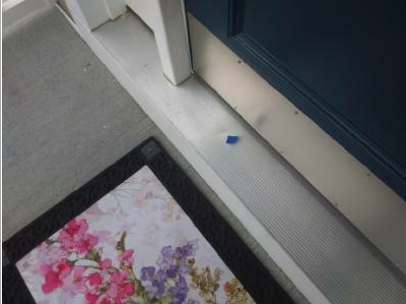
Front door threshold plate is dented.

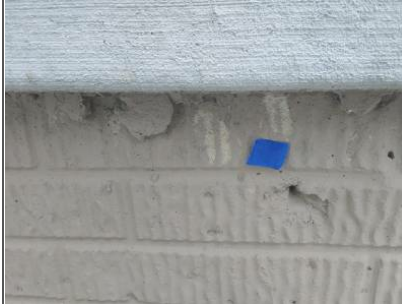
Paint is inconsistent under left side of front porch on foundation.

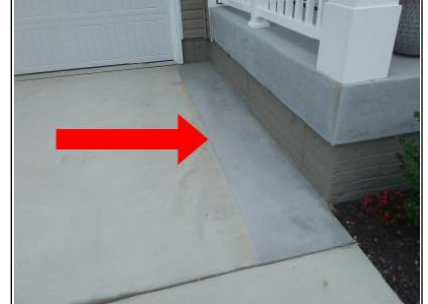
Finish on driveway surface at porch is inconsistent with the rest of the driveway.

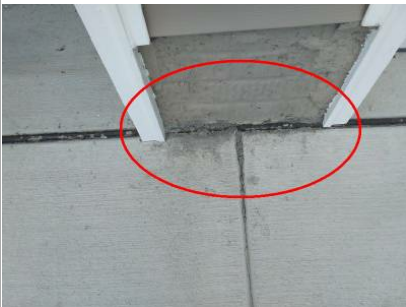
Concrete splatter on surface between garage doors.

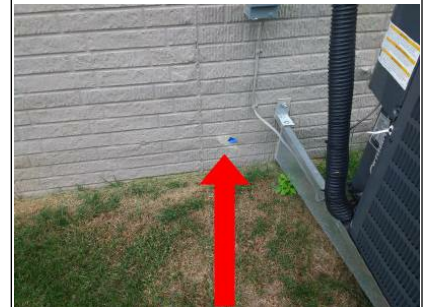
Paint missing on foundation to the left of the compressor.

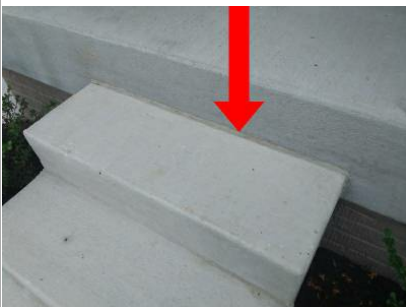
Expansion joint at top of steps inconsistent with the rest of the neighborhood. Ask builder for explanation of types of materials used.

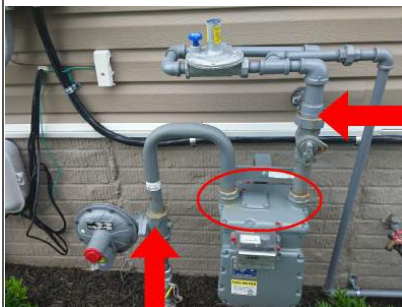
Gas meter supply lines are rusting.

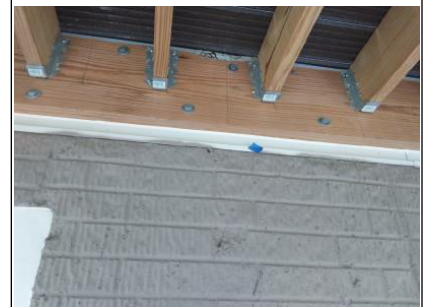
Paint over spray on flashing below the deck.

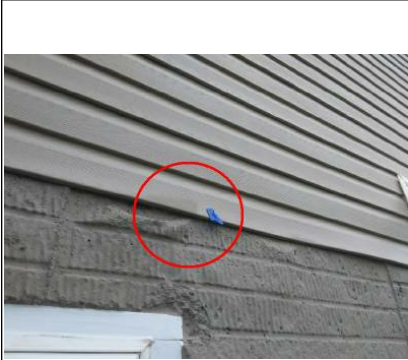
Paint over spray on siding on the back of the house.

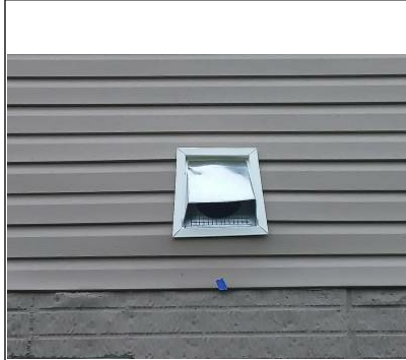
J channel not square around vent on the back side of the house.

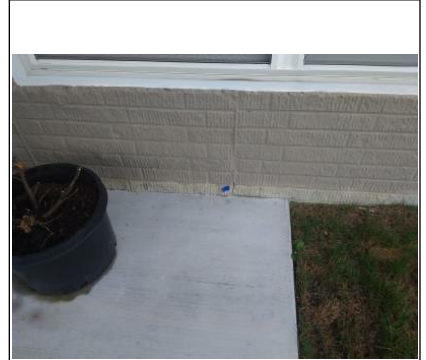
Foundation not painted above the patio surface.

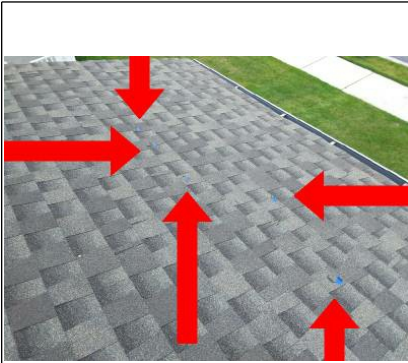
Surface of porch roof on the front of the house is damaged in several locations from ladder footings.

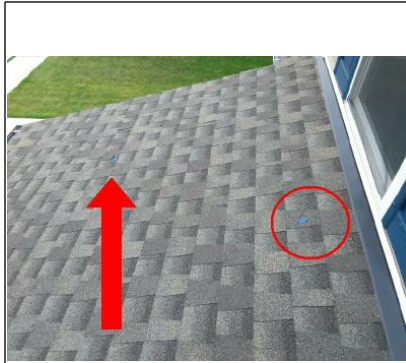
Surface of roofs damaged in 2 locations to locations to the right of the window.

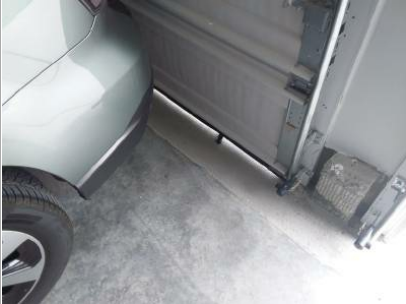
Contact auto reverse on the garage door in the right bay as you face the house does not work. This is a safety hazard.

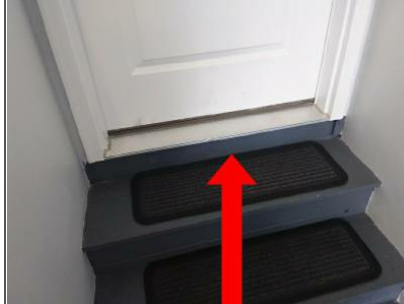
Threshold plate support board under the fire door is missing.

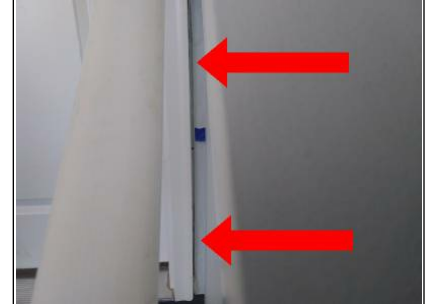
Fire blocking to the right of the egress door is missing/incomplete.

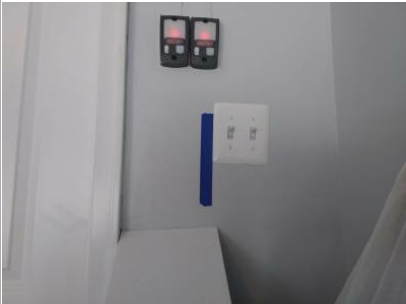
Switch plate to the right of the fire door is crooked.

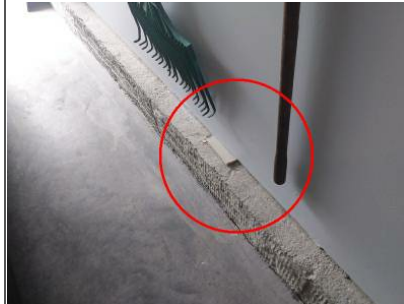
Shim under drywall and left bay should be removed.

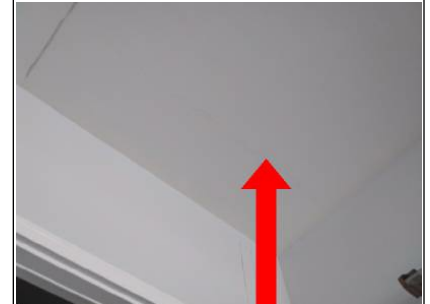
Crooked crack in drywall on ceiling above fire door. Monitor and repair as necessary.

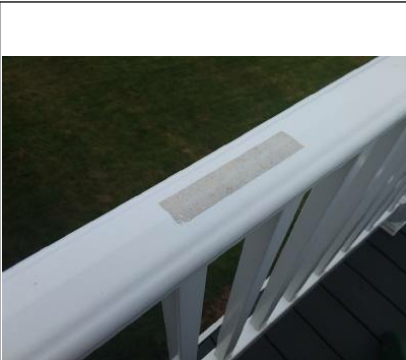
Glue marks on all 7 sections of railing around the deck.

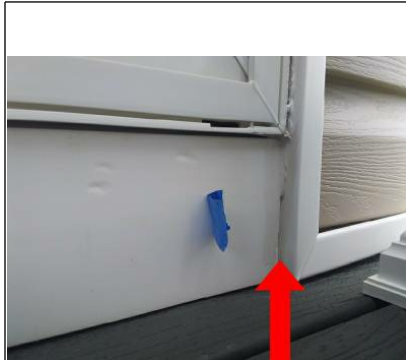
Threshold plate is loose and there is a gap between the threshold plate and the J channel on the right side of the sliding door.

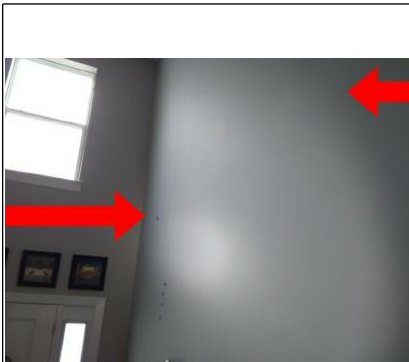
Drywall seam above front door  
between arrows.

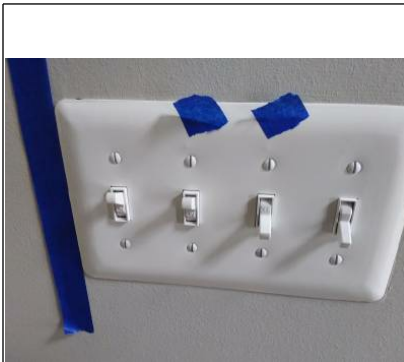
4 gang switch plate is  
overtightened creating dents.  
Switchplate is crooked.

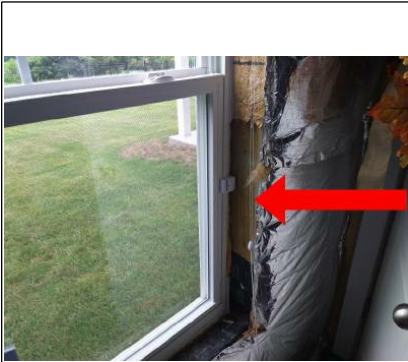
OSB broken off right side of window frame at rear window in workshop.

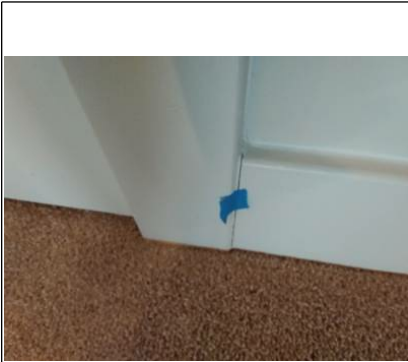
Gap between base mold and door casing underneath of the steps.

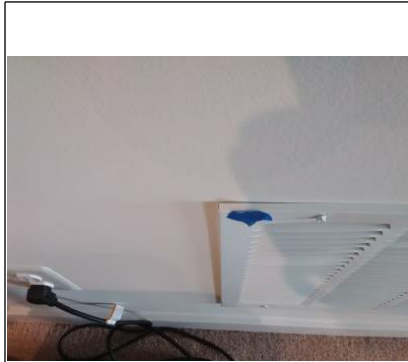
Return is not flush to the wall right of the utility room door.

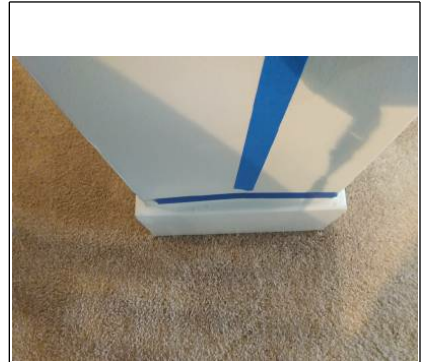
Bow in post closest to the desk.

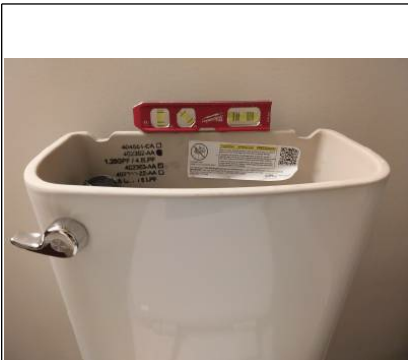
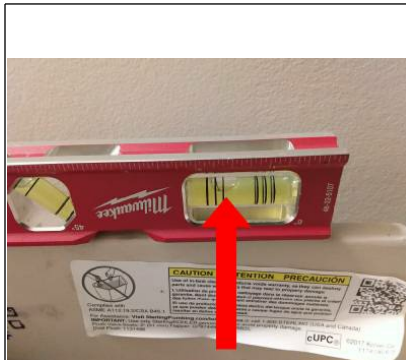
Toilet tank is not level, is pitched to the right.

Close up of level.

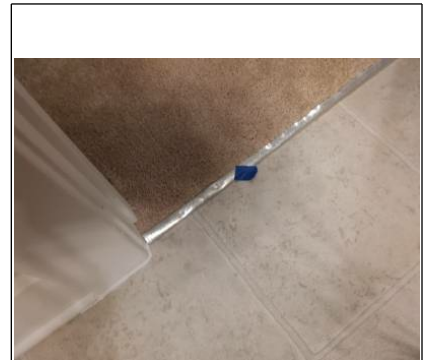
Transition strip is dented in several locations.

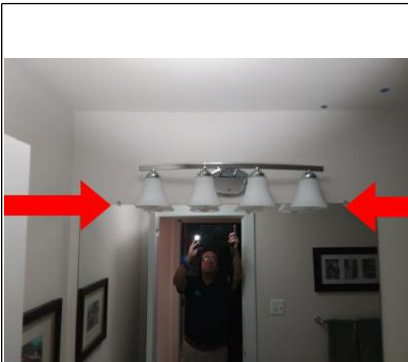
Light fixture should not overlap the mirror.

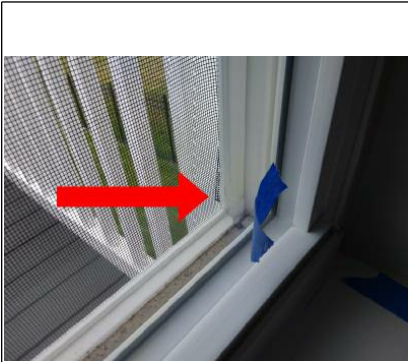
Screen not trimmed on right rear window.

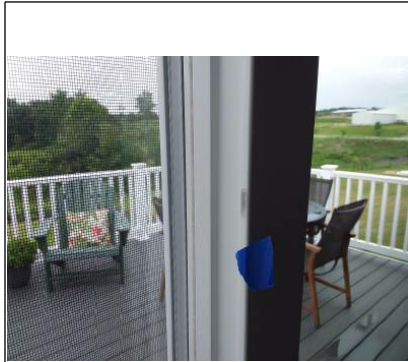
Scuff mark on sliding door.

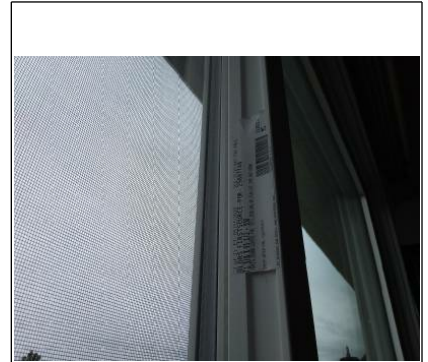
Manufacturers label left on sliding door.

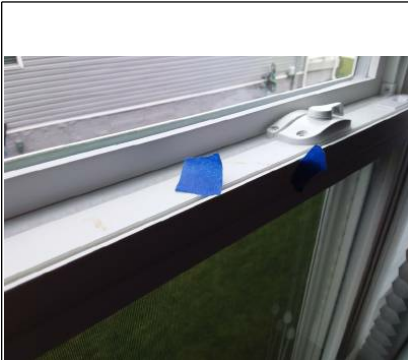
Glue marks on bottom left window sash.

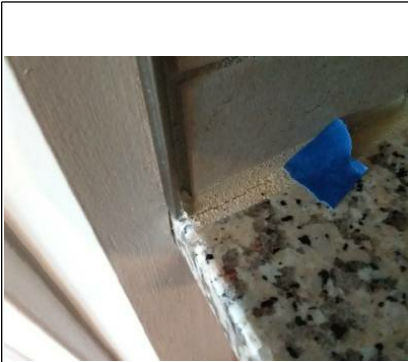
Grout crack between backsplash and counter to the left of the refrigerator.

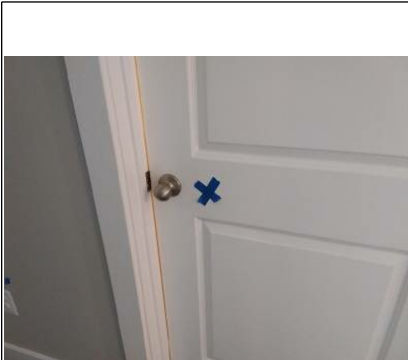
Laundry room door ghosts closed.

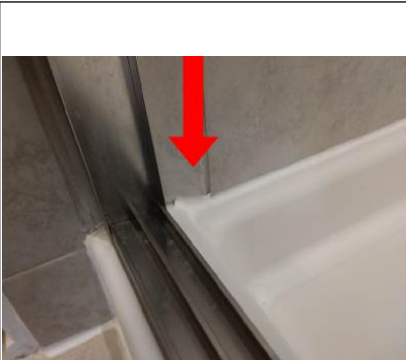
Weep holes in shower are not open.
