# Home Inspection Report

2205 Connor St, Mount Airy, MD 21771

Thursday August 12, 2021

0812 G

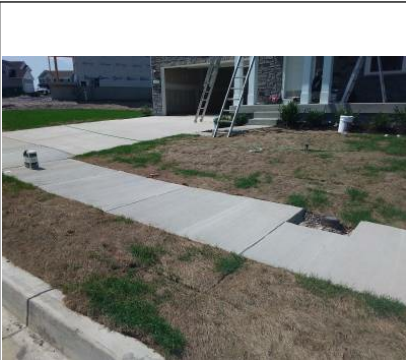
Sod in the front yard is dying.

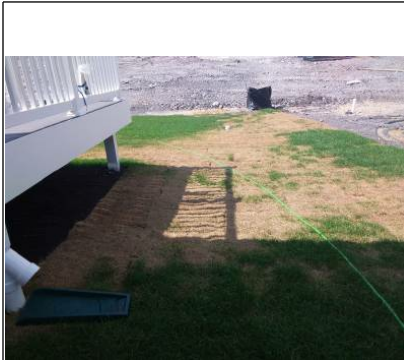
Dying sod on the right rear of the house.

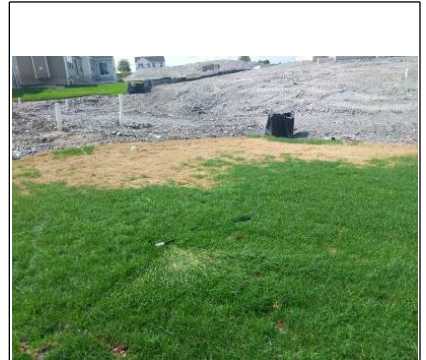
Dying sod on the left rear of the house

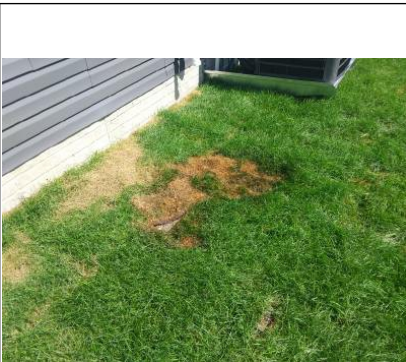
Dead sod next to the compressor.

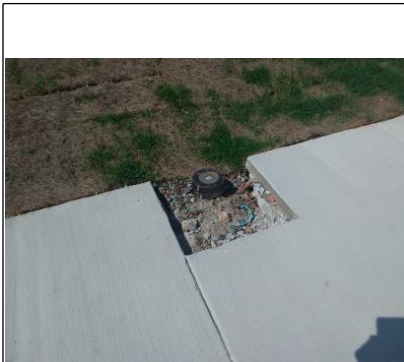
Sidewalk is incomplete.

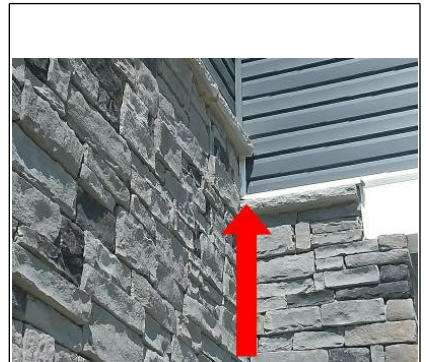
Metal flashing lifted at sill above the front porch on the left near garage.

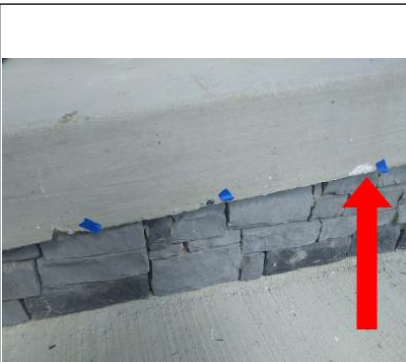
Chips out of bottom of the front porch, arrow points to paint spill.

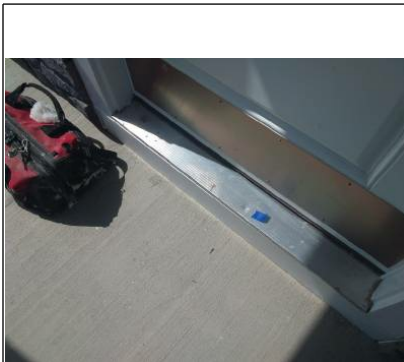
Front door threshold plate is dented and scratched.

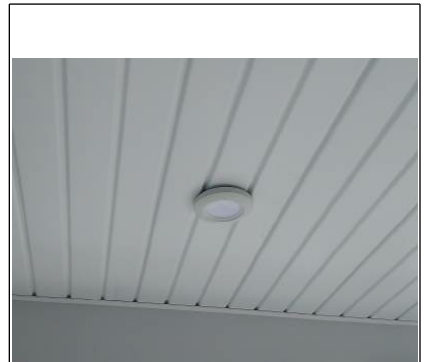
Light fixture outside of front door is not flush to the ceiling.

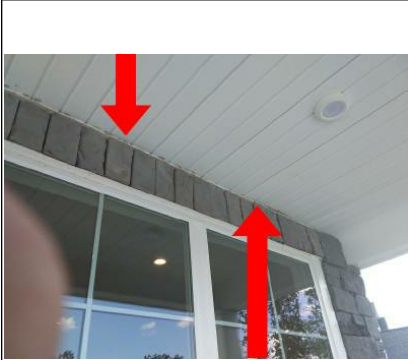
Mortar on the ceiling above the stone.

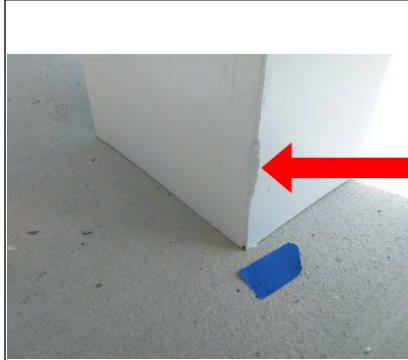
Damage to basemold on left of is left of front steps.

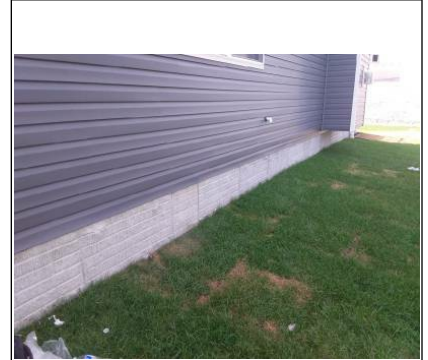
Foundation is not painted.

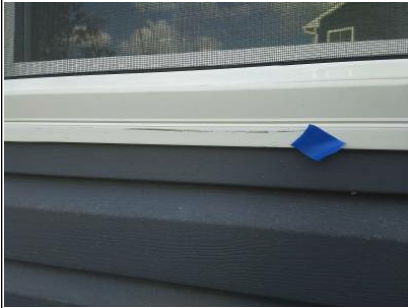
Molding is scratched under right side double windows.

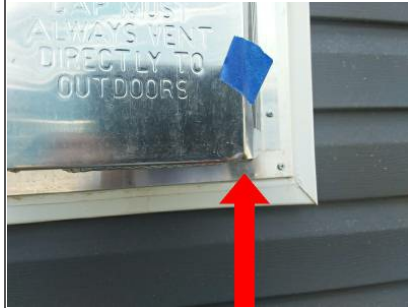
Bottom right corner of fireplace vent is dented.

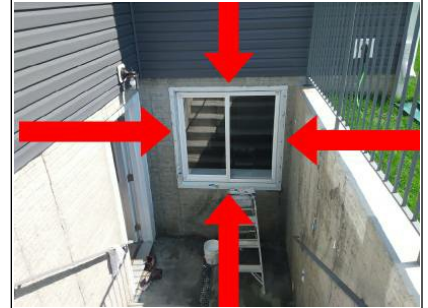
Exterior trims/casing around the egress window are not installed.

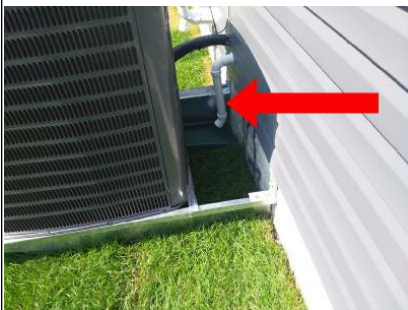
Sump pump discharge is terminating below grade behind the air handler. Recommend adding an extension to get water away from the house. Check for proper pitch. The alternative is to move the position of the discharge line.

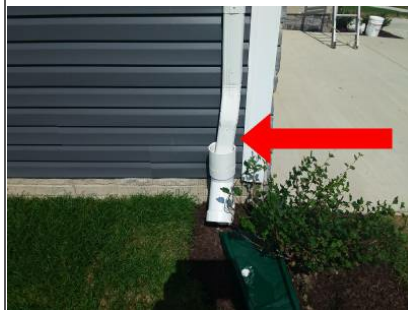
Front left downspout is not plumb.

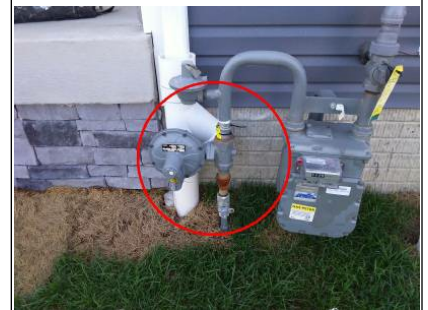
Gas supply line is rusting and should be painted.

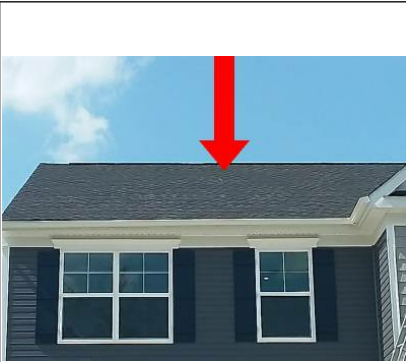
There is a piece of debris on the front roof on the left side at the arrow.

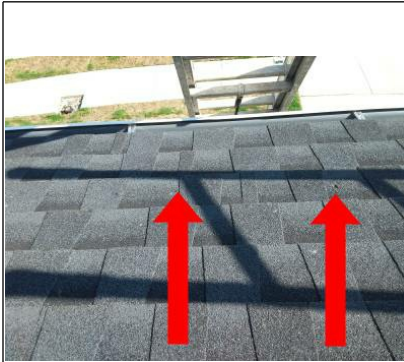
Damage to shingles from ladder footings as seen from the bonus room window

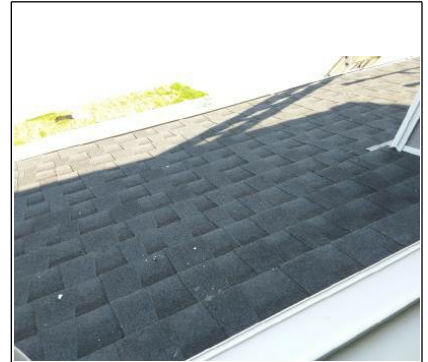
Paint and caulk spills in several locations on the front lower roof.

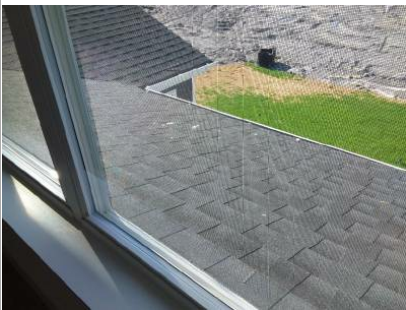
Rear roof has paint spills on it.

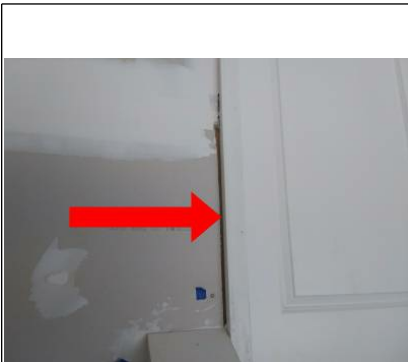
Gap between drywall and casing on the left of the fire door.

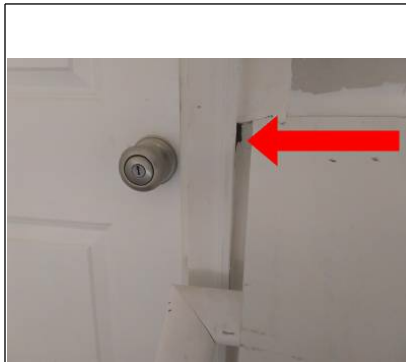
Gap between drywall and casing on the right side of the fire door.

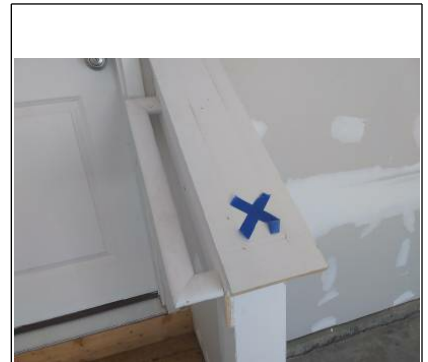
Top right plate on staircase is loose.

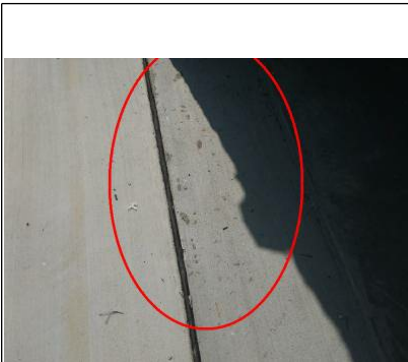
Concrete splatter on garage apron

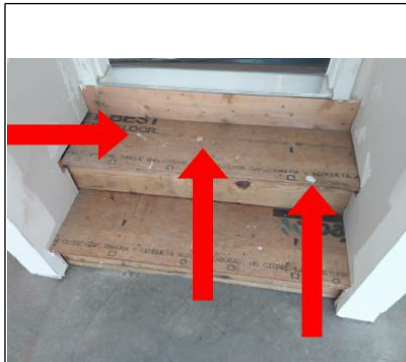
Raised surfaces on garage steps.

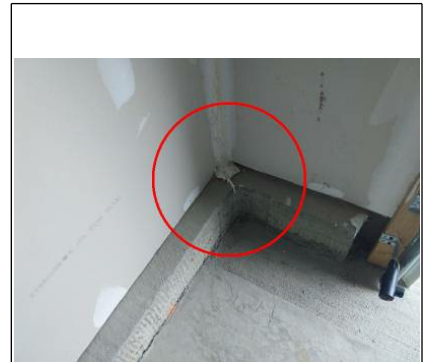
Poor finished to dry wall on front left corner.

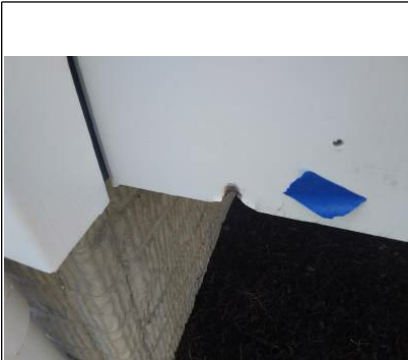
Gouge out of fascia board close to the house on the left side.

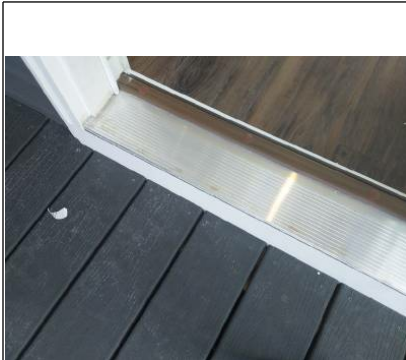
Threshold plate is tarnished.

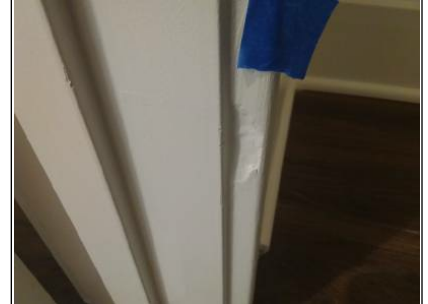
Casing next to bottom hinge on left door of coat closet is damaged and poorly repaired.

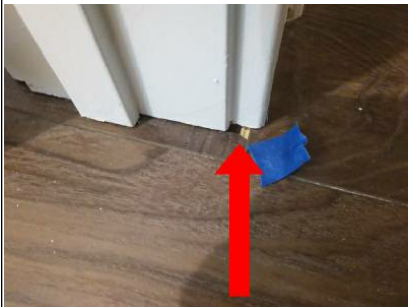
Flooring is cut short on inside of coat closet at the bottom of the left side of the door casing.

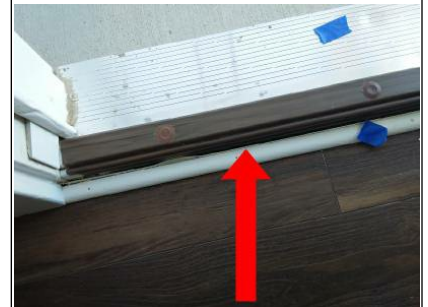
Gap between threshold plate and shoe mold at front door.

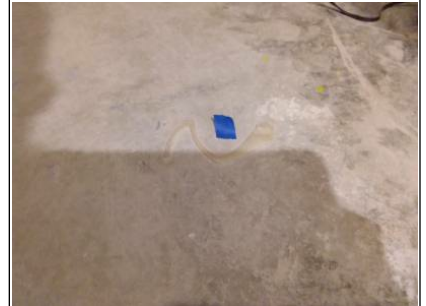
Liquid nail spilled on the floor.

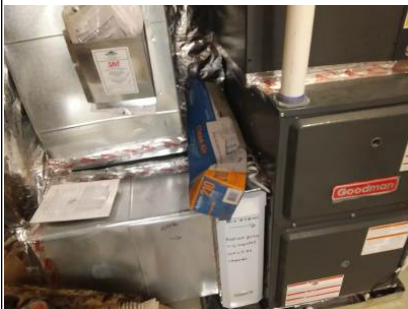
There is no backup filter left on the air handler.

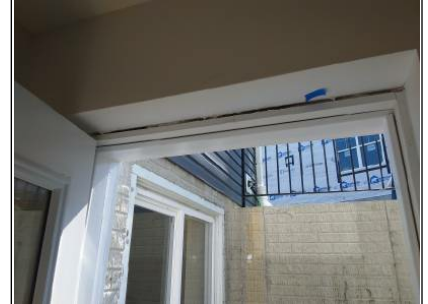
Dry wall not finished above egress door.

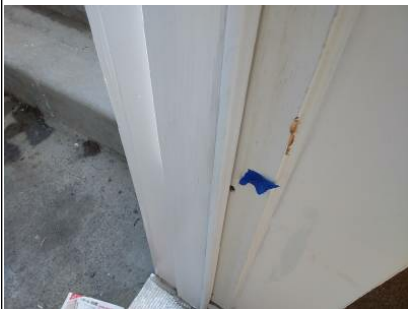
Casing damaged and screw holes not filled on right side of egress door.

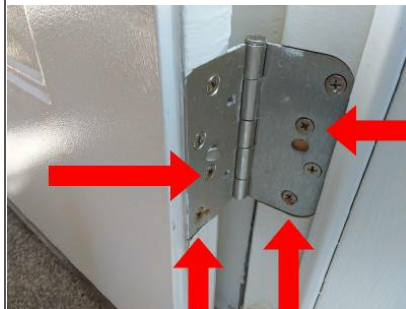
Screws are rusting on bottom hinge of egress door.

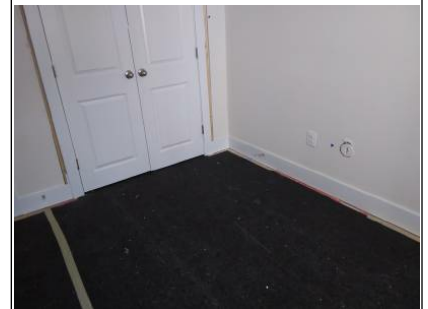
Basement bedroom is still a work in progress.

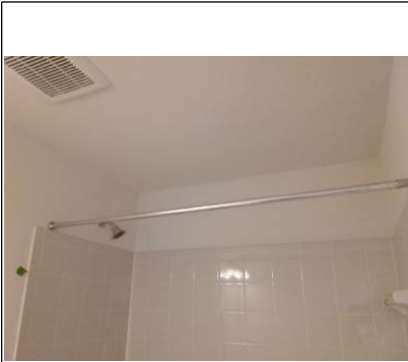
There is no light fixture over the tub and shower

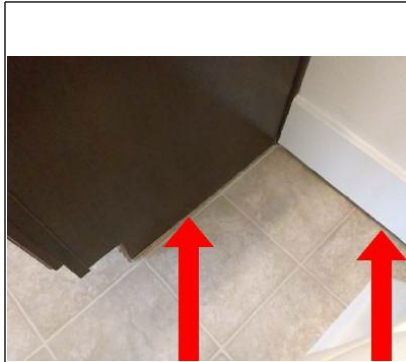
Shoe mold is missing around the vanity and and the base mold.

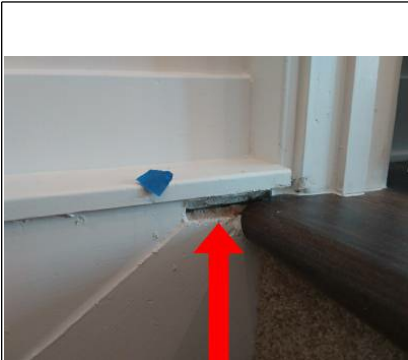
Gap on left side at the top of the stringer on the stairs from the basement.

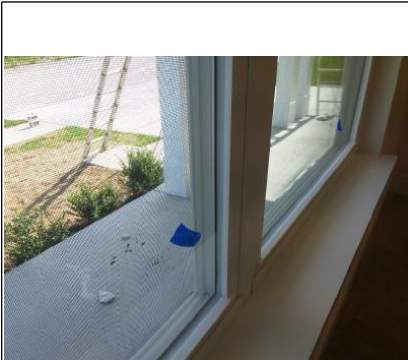
Concrete splatter on front windows and screens.

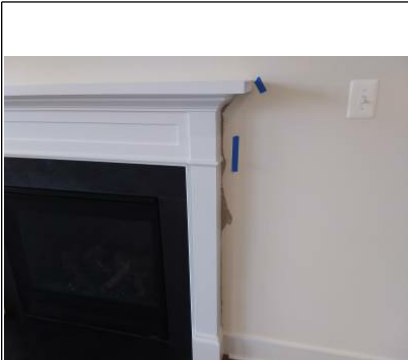
Pour drywall finish on the right side of the fireplace.

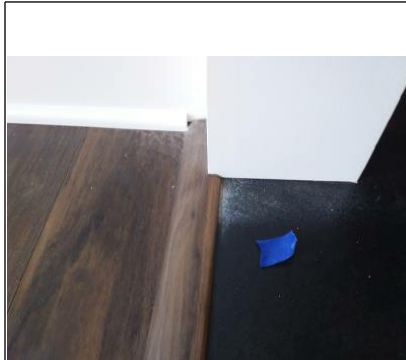
Paint over spray on left side of fireplace hearth.

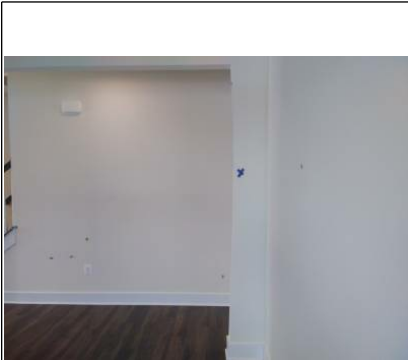
End of wall on right side of dining room opening is bowed inward.

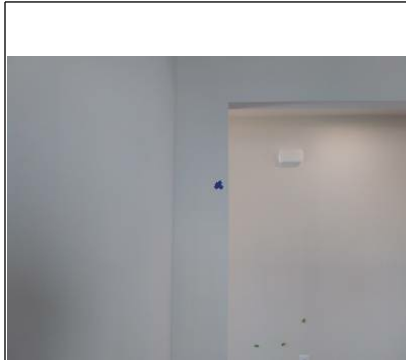
Top of wall on left side of dining room opening is bowed

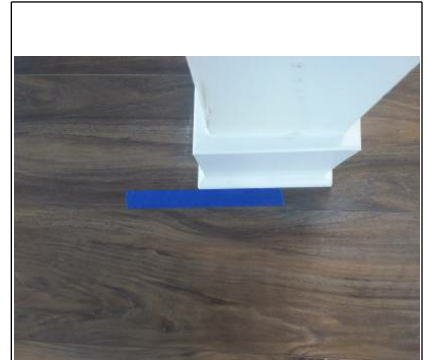
End of wall on left side of dining room opening is out of square.

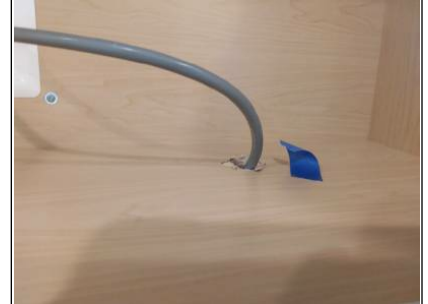
Cabinet penetration above the microwave should be sealed.

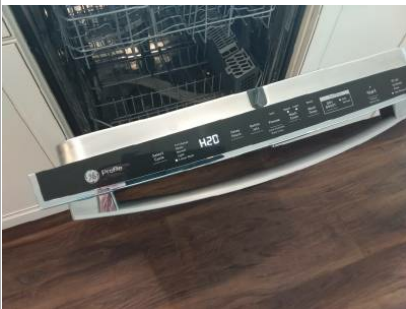
No water supply to the dishwasher.

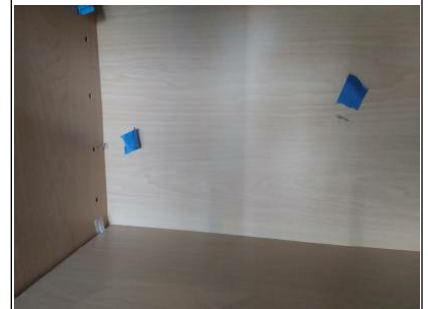
Sharp ends of nails sticking through back of base cabinet for island closest to the family room.

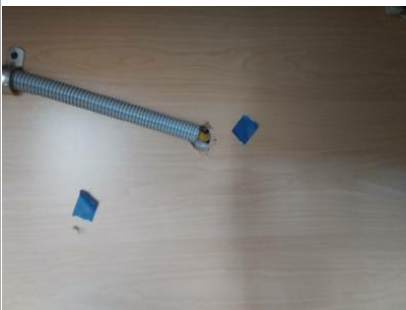
Penetration for power supply on the end of the island is not sealed.

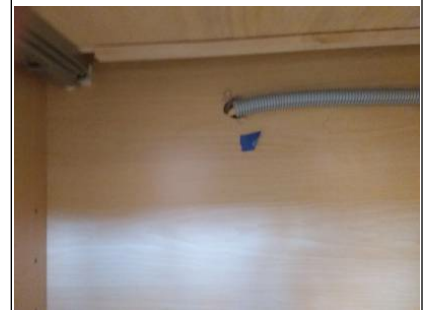
Cabinet penetration not sealed under island closest to the range

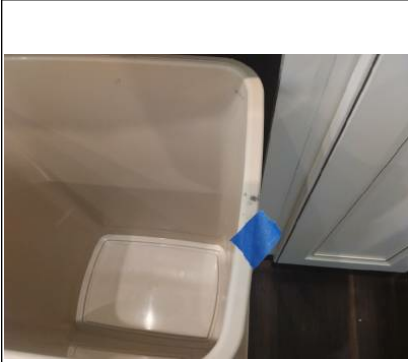
2nd trash can is dirty.

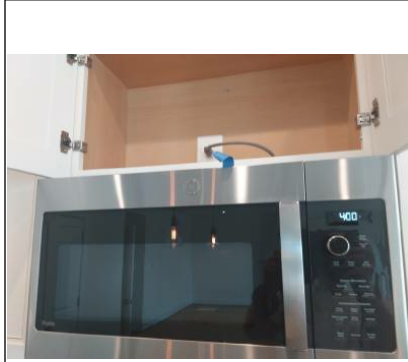
Exhaust fan on microwave does not exhaust to the exterior.

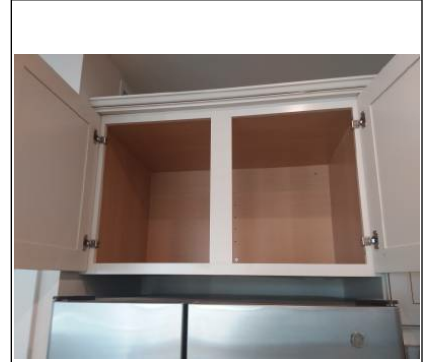
Shelf is missing in cabinet over the refrigerator.

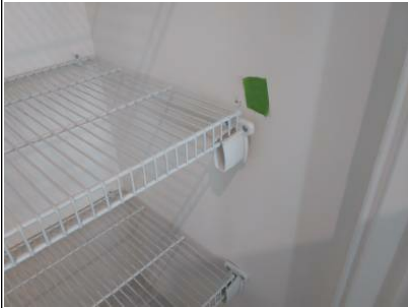
Shelf bracket not properly installed in pantry.

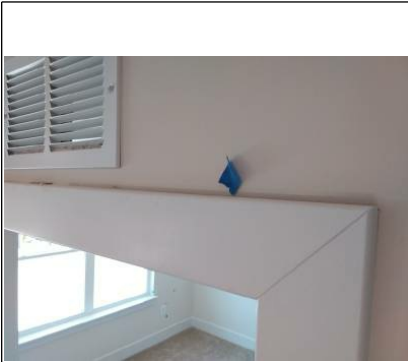
Paint is poorly finished above all door casings for bedroom's, bathroom and laundry room on upper level both inside and out.

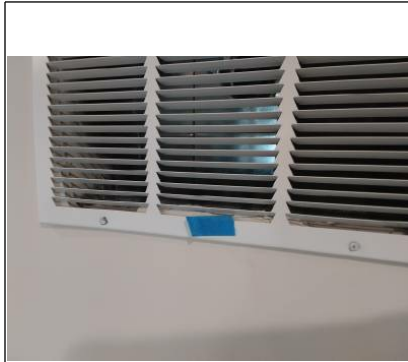
Hole cut for return at the top of the steps is not big enough.

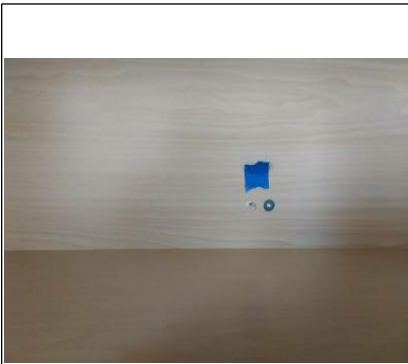
Extra hole punched for wall cabinet.

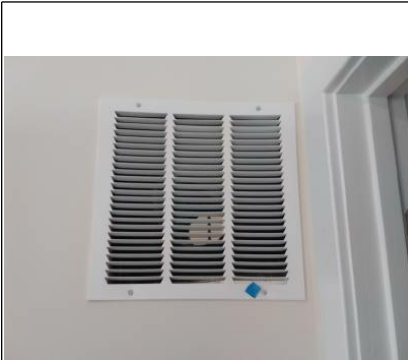
Hole not completely cut and return grate is crooked next to closet.

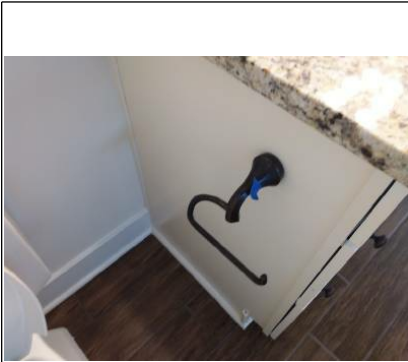
Toilet paper holder is loose

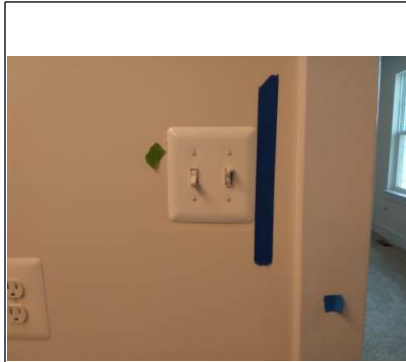
Two gang switch plate is loose.

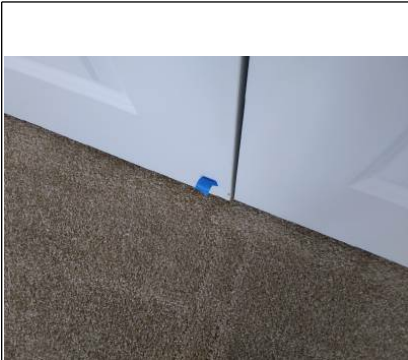
Front right bedroom, closet door  
reveal is uneven

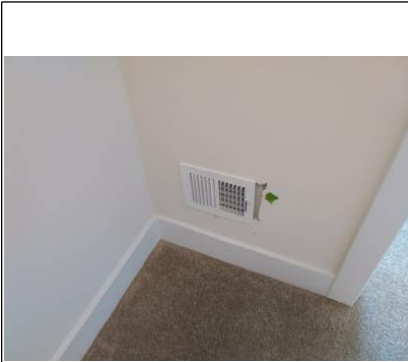
Drywall incomplete on supply vent in closet of front left bedroom.

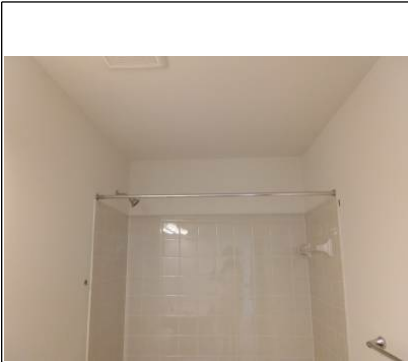
There is no light fixture above the tub.

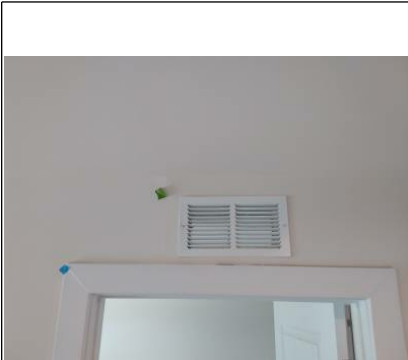
Return vent over front left  
bedroom is not level
