Home Inspection Report

622 Trango Dr, Westminster, MD 21158

Tuesday July 7, 2020

0707 B

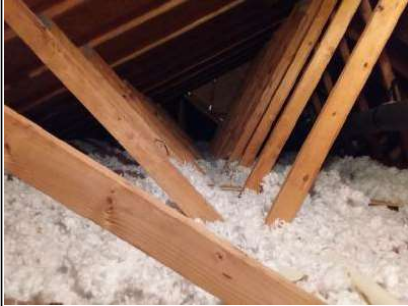
Blown in insulation in the attic is 14 to 18 inches deep. This translates to R38 insulation which is appropriate for this region.

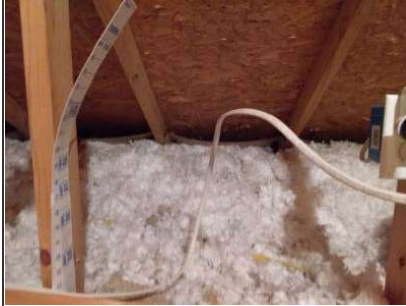
Second view of insulation in the attic.

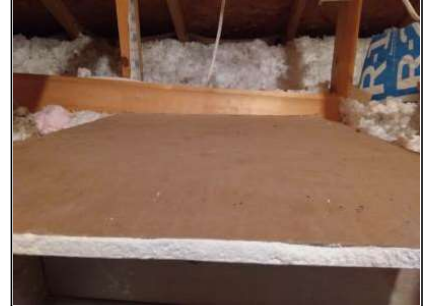
Cover panel for the attic access should be insulated.

- the attic cover panel should be insulated.

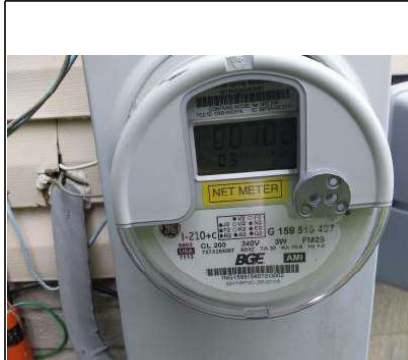
Electric service is 200 amps

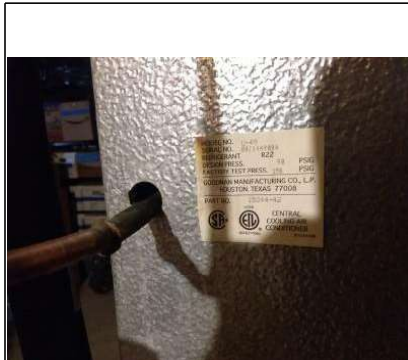
Legal tag

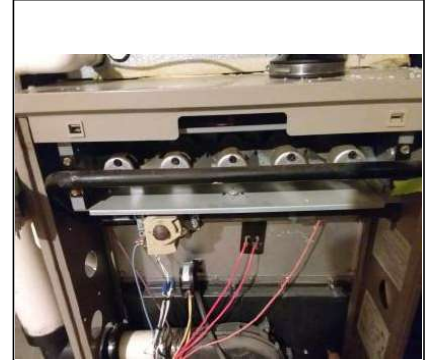
View of the burners.

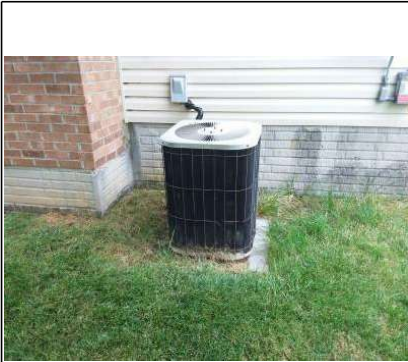
Compressor unit

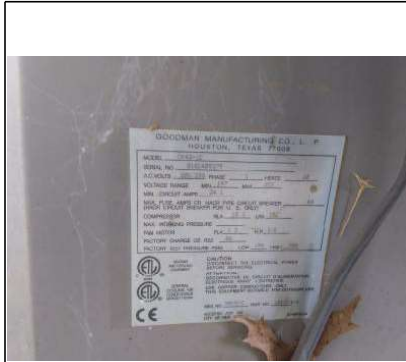
Legal tag

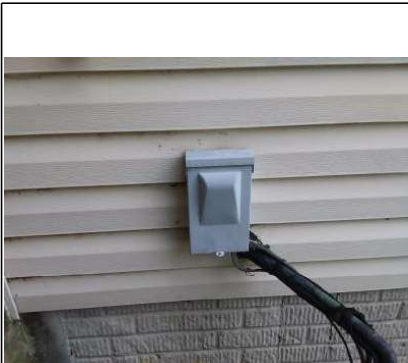
Outdoor shutoff

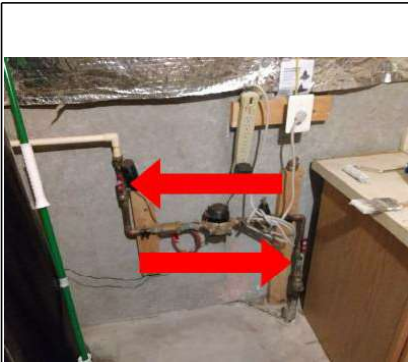
Main water service entry. Right arrow is shut off before pressure control valve and left arrow is shut off after pressure control valve.

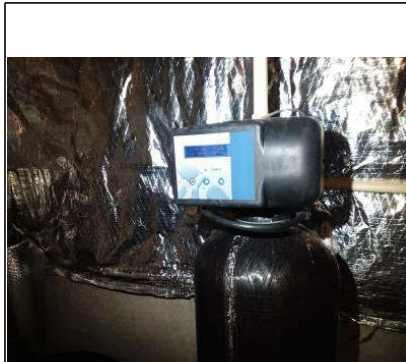
Water purification system.

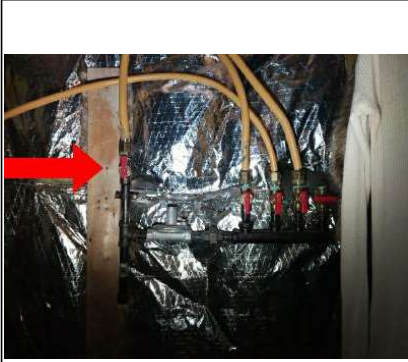
Main fuel shutoff

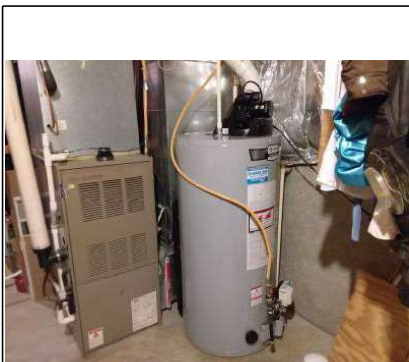
Water heater.

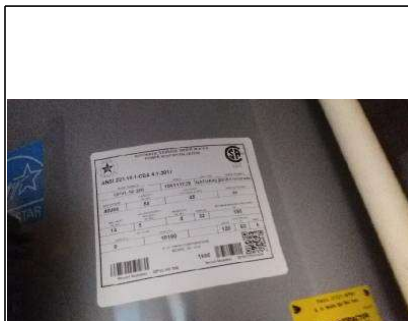
Legal tag.

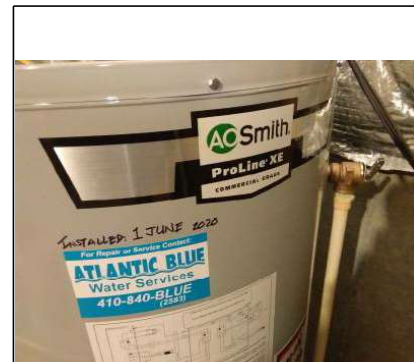
AO Smith

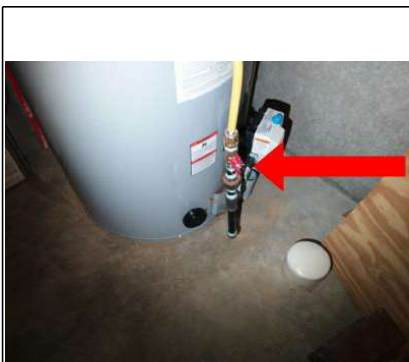
Gas shutoff valve.

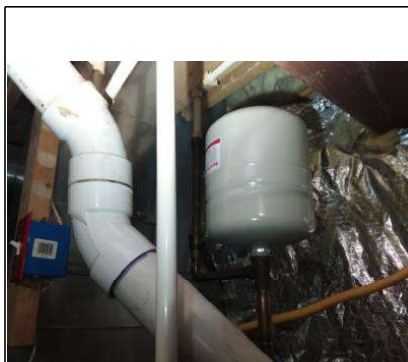
Expansion tank.

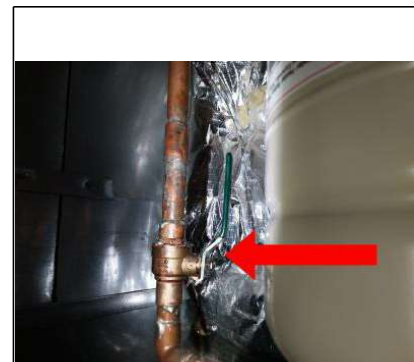
Water shutoff

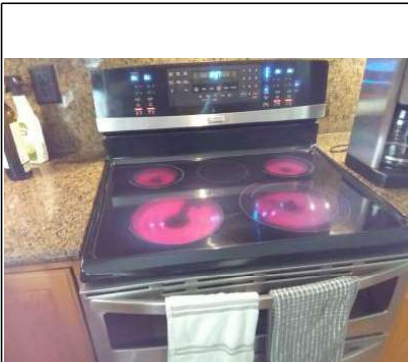
All burners work on the range.

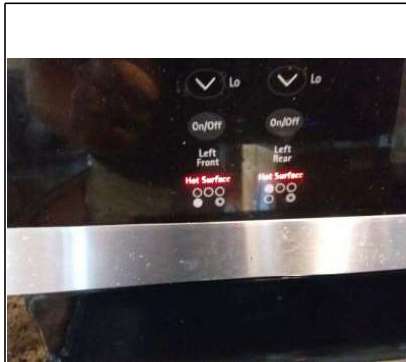
Hot surface warning lights work

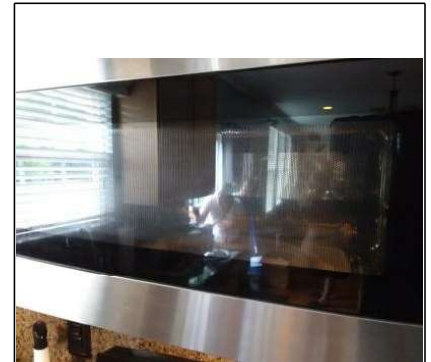
Microwave worked at the time of the inspection

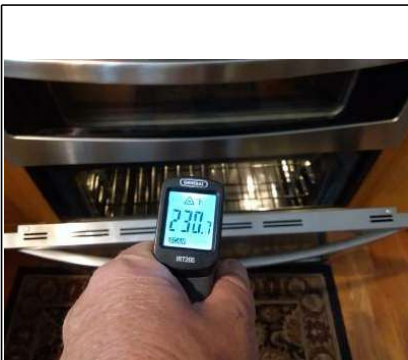
Oven heated to 230 degrees in 3 minutes

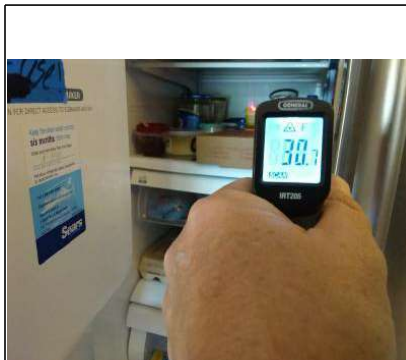
Refrigerator is 30.7 degrees.

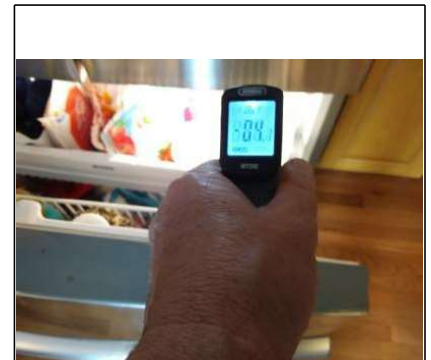
Freezer is -4.1 degrees.

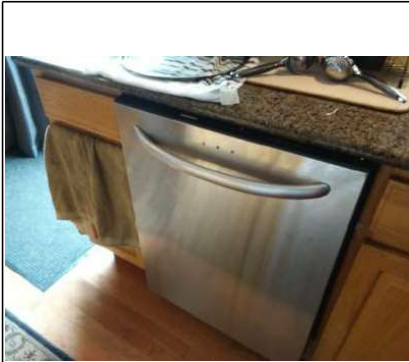
Dishwasher worked at the time of the inspection.

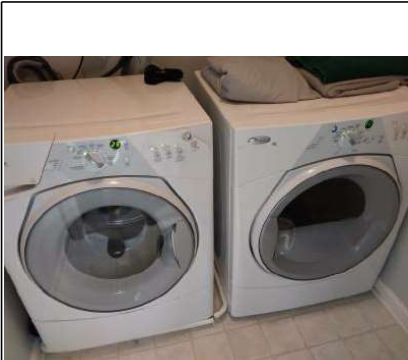
Washer and dryer worked at the time of the inspection

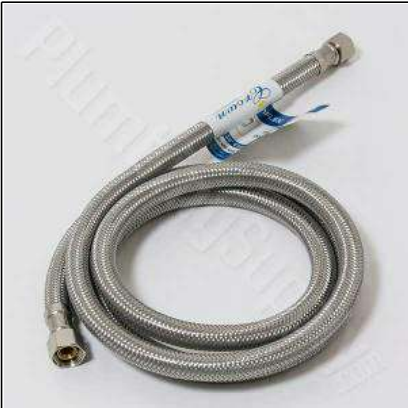
Metal-reinforced supply lines.

After closing, recommend that water supply lines be replaced with metal reinforced water supply lines. See attached picture.

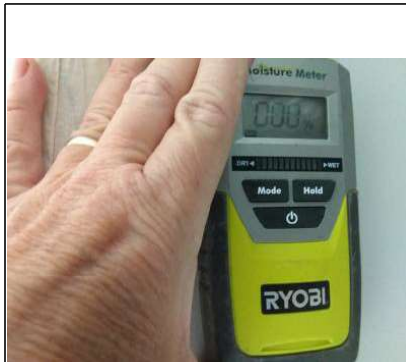
Moisture reading on the flat wall is 0%
