Home Inspection Report

1200 Iroquois Dr, Crownsville, MD 21032

Wednesday August 4, 2021

0804 E

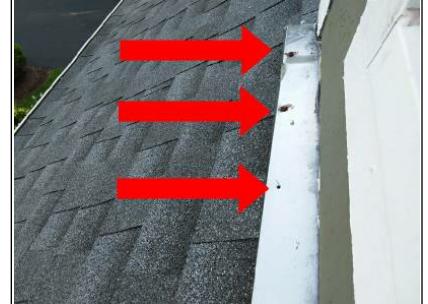
2nd view of holes in flashing under windows that need to be sealed.

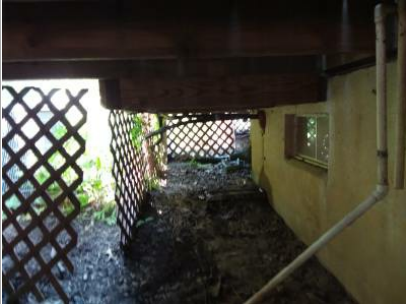
Both additions to the left side of the deck do not have the proper components to give the necessary support. Footings and posts should be added.

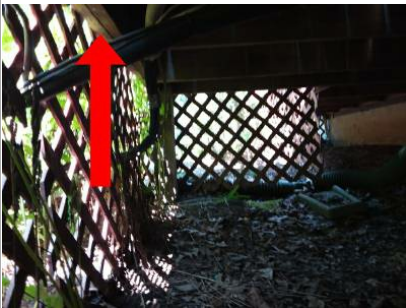
Posts need to be added to make the deck independent of the other decks. Note that the double joists on the front end of the deck serve as a beam and a joist at the same time.

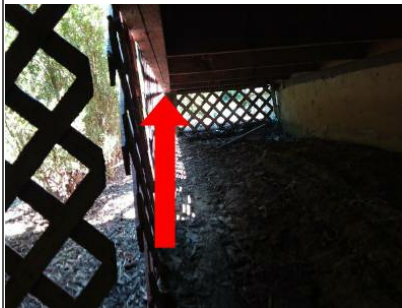
The double joist/beam should be supported on both ends. This will make the structures independent of each other with their own support systems

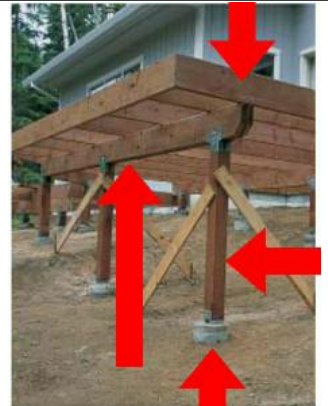
From bottom to top, footing, post, beam, joist. The exception is that if a joist is doubled and supported by weight bearing posts on 2 positions come, it can serve as a joist/beam combination.

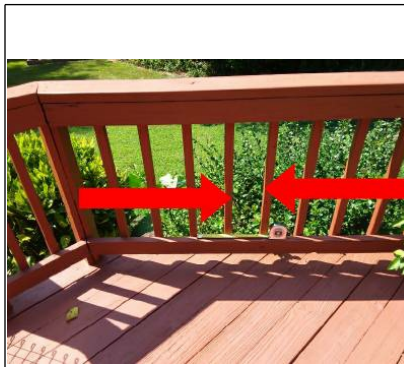
- The 2 sections extending on the left side of the deck should be evaluated by a qualified contractor who can make the necessary repairs. Details are in the report.
- The stringers for the main staircase are not properly spaced.
- The balusters on the railing are not properly spaced.

Spacing between balusters should be no more than 4 inches.

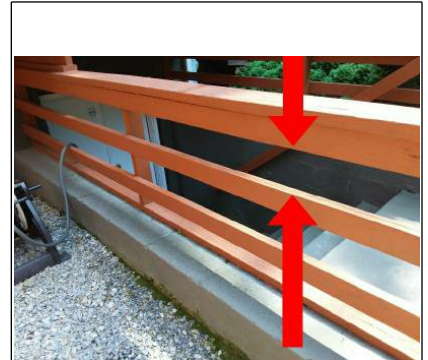
Gaps in railing on the side of the staircase should be 4" apart.

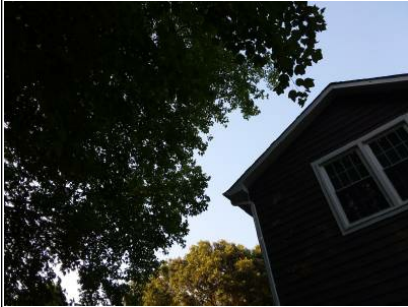
Trees overhanging the house should be clear to protect the integrity of the roofing material.

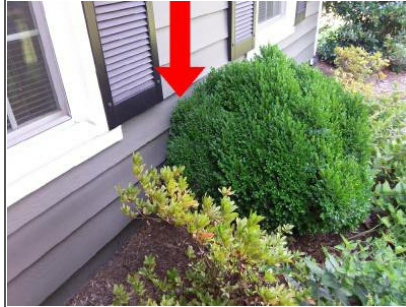
Vegetation should be kept 12 to 18" clear of the house structure to protect the integrity of the building materials.

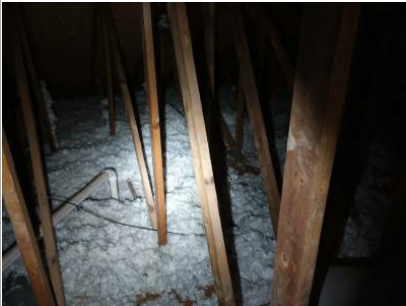
Insulation in the attic is inconsistent in depth. It should be between 14 and 18" thick throughout to achieve an R49 installation rating.

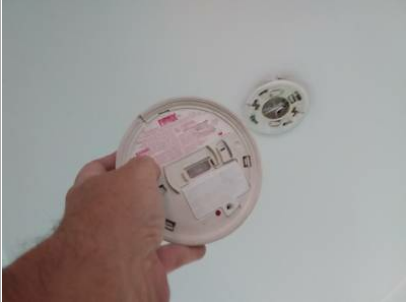
The smoke detectors throughout the house need to be updated. The smoke detectors should be hardwired, interconnected combination smoke and carbon monoxide detectors with a sealed 10 year lithium ion battery backup. Smoke detectors should be changed every 10 years.

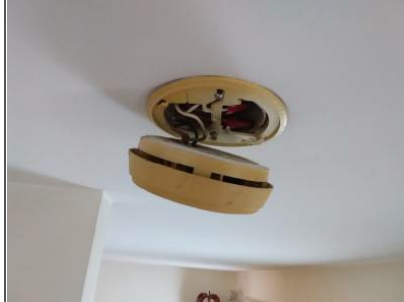
View of the older hardwire smoke detector at the bottom of the steps in the foyer.

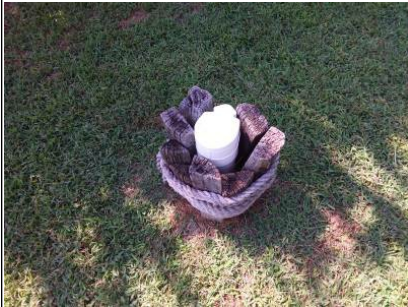
Position of well head in the front yard.

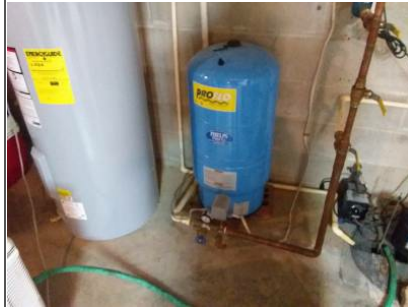
Pressure tank

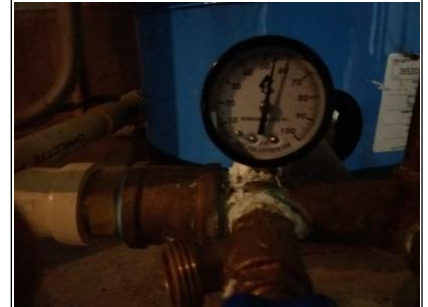
Well pressure at 55 PSI

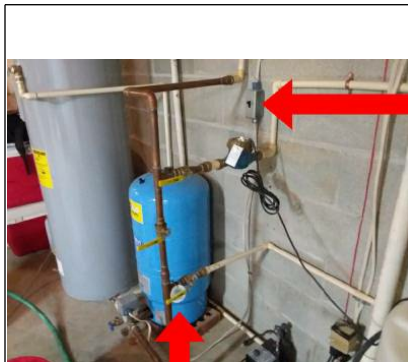
Water shutoff, switch for well pump

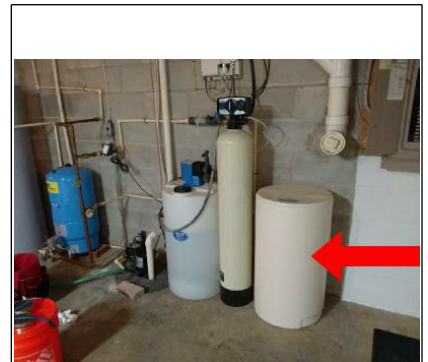
Water softener, salt reservoir

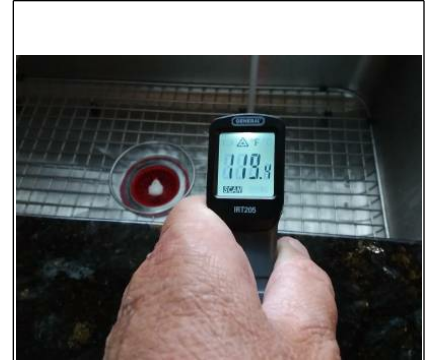
Water temperature is 119.4 degrees at kitchen sink.

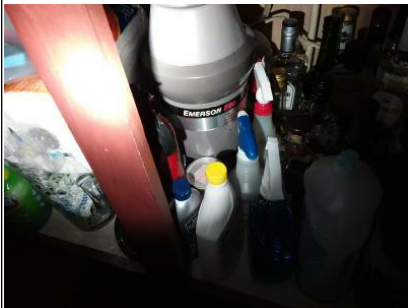
Garbage disposal worked

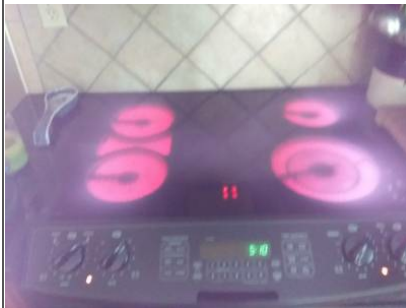
Range worked

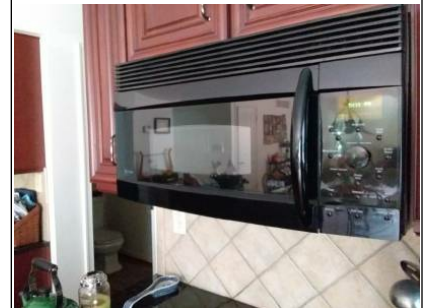
Microwave worked. Note that the fan recirculates air back into the kitchen.

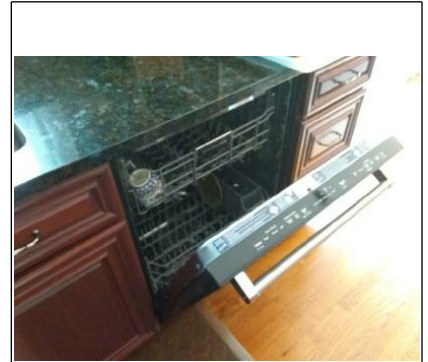
Dishwasher worked

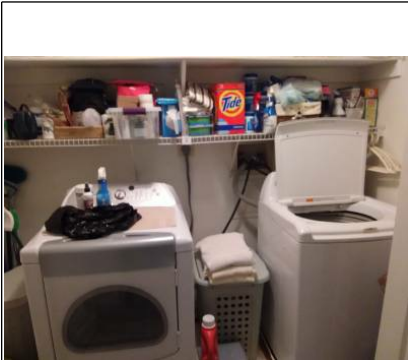
Washer and dryer worked.

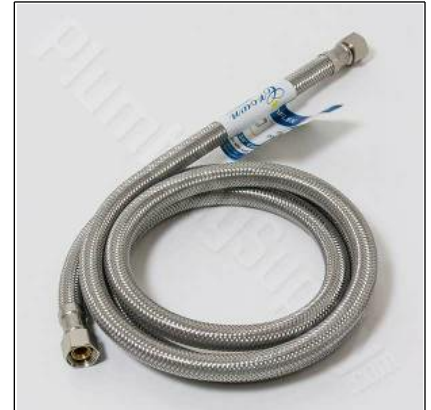
Reinforced supply line
