# Home Inspection Report

2205 Connor St, Mount Airy, MD 21771

Thursday August 12, 2021

0812 G

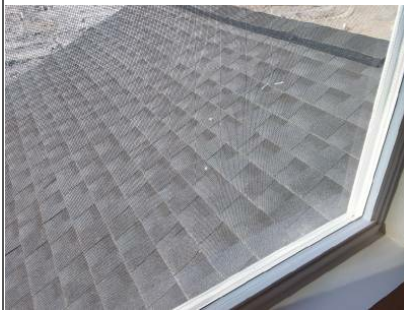
Debris on roof as seen from master bedroom window.

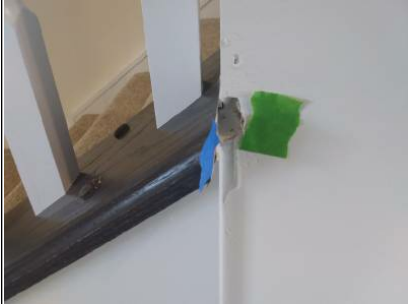
Incomplete drywall at top of bottom rail to upper level.

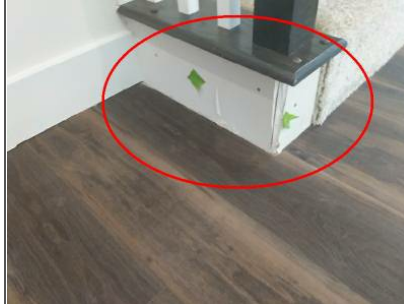
Bottom of landing in foyer is incomplete.

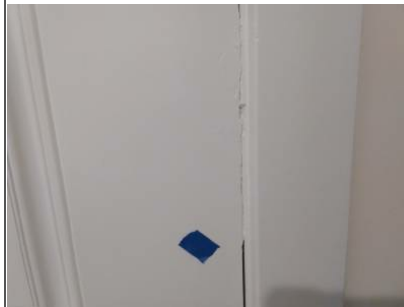
Sloppy finish on hinge side of front door.

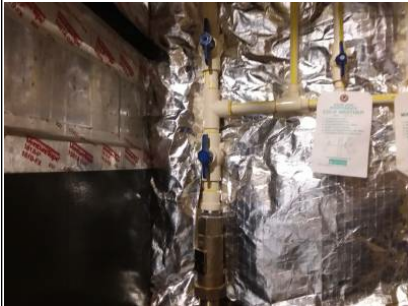
Main water shut off is not clearly marked.

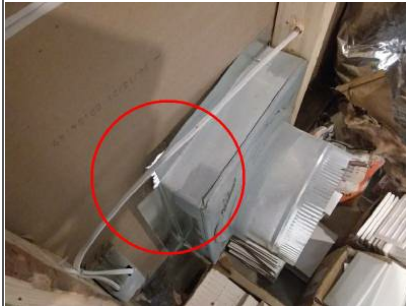
Return is not properly set to the wall.

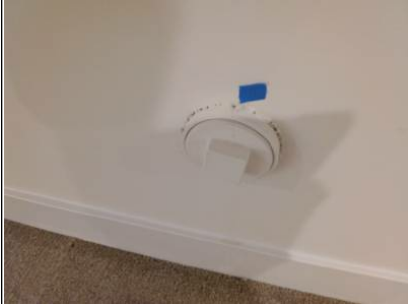
Rough finish around drain line clean out.

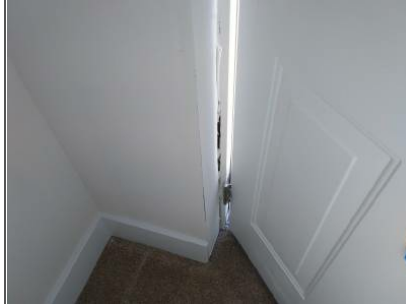
Drywall not finished behind egress door

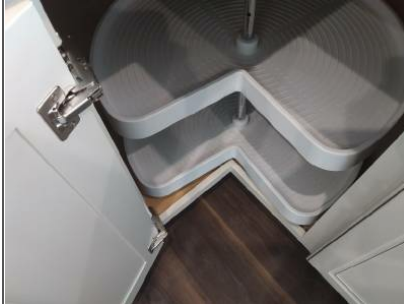
Lazy Susan shelves do not come to rest in the center.

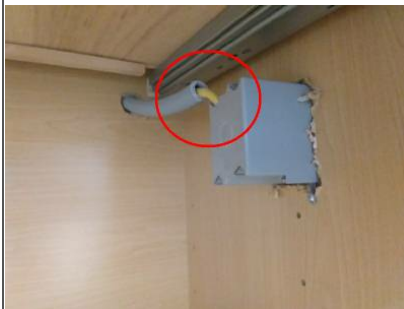
Gap between conduit and Junction Box on the end of the peninsula.

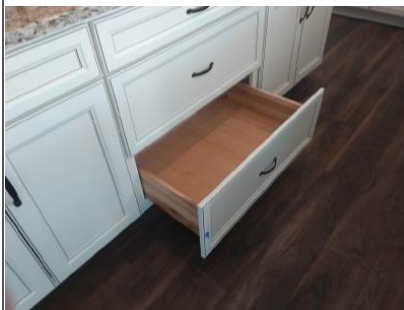
Bottom drawer on island drags when opened and closed.

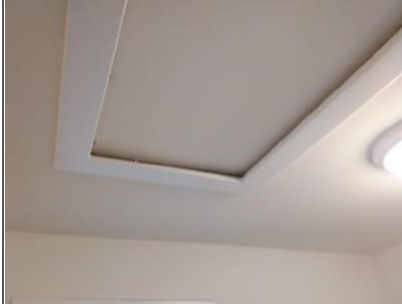
Screws holding attic access panel open.
